CONSERVATION OF THE MURAL PAINTINGS OF THE GREEK ORTHODOX CHURCH DOME OF SAINT GEORGE, OLD CAIRO-EGYPT

Abstract

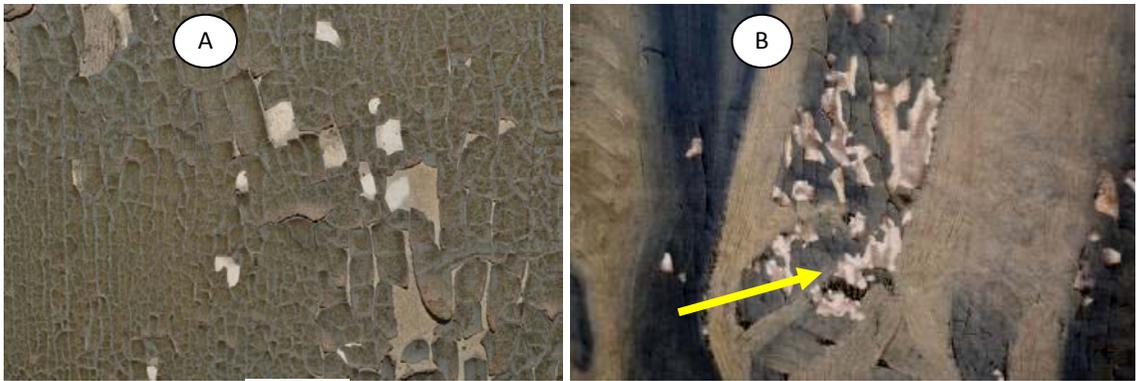
(powdering) and the paint layer start to flake (fig.6), because of the oil content of paint is inadequate (Kabbani 1997). Also humidity, by both infiltration and capillarity, is responsible for the loss and cohesion of the support and paint layers. Liquefaction of some colors on the other colors was noticed (fig.7) due to wash of color by the rain penetration through the cracks or holes in the walls, ceiling and the broken windows. Chromatic alterations (changes in appearance) were observed (fig.8). Unfortunately, oxygen in the air oxidizes the varnish and turns it into a yellow film that dulls the colors that it once enhanced. The paint layer had also suffered scratches (fig.9), which in several places had penetrated the intonaco layer. Mildew discoloration was the common problems at the mural painting of St. George. It showed a phenomenology of alteration varying from white, brown, and black duff patinas (fig. 10a,b). These phenomena might be linked to different microbial colonization. Mildew is caused by forms of stain fungi. The high level of moisture favored the appearance of biological attack on the mural surface, both on Christ and Apostles. According to the analysis, fungal species such as *Penicillium*, *Aspergillus* and *Alternaria* were present on the painting. The dome comprises inorganic and organic materials such as blood of bats (bats dropping), bird's nests, bee's nests...etc. (fig.11a, b). Dirt, impurities stains, insect broods and numerous cobweb nests on the painting surface were registered (fig12), due to the accumulation of airborne deposits from different sources on the surface of the painted dome, this has caused the formation of dark film which obscure and deadens the original pigments (fig.13). The result is a vulnerable, rapidly deteriorating surface that is difficult to read pictorially.

Figure6: Losses of cohesion (powdering), paint start to flake.

The fixation of the paint layer was imperative due to the high degradation level which would definitively have led to large losses. For the powdering areas the Paraloid B.72 was sprayed on the surface (fig. 32a, b). Depending on the absorption level of the paint layer some alcohol was sprayed before for a better penetration. After the fixative was totally absorbed by the paint layer the surface, the surface was pressed back into its original position using a protective sheet of silicon paper and cotton sheets

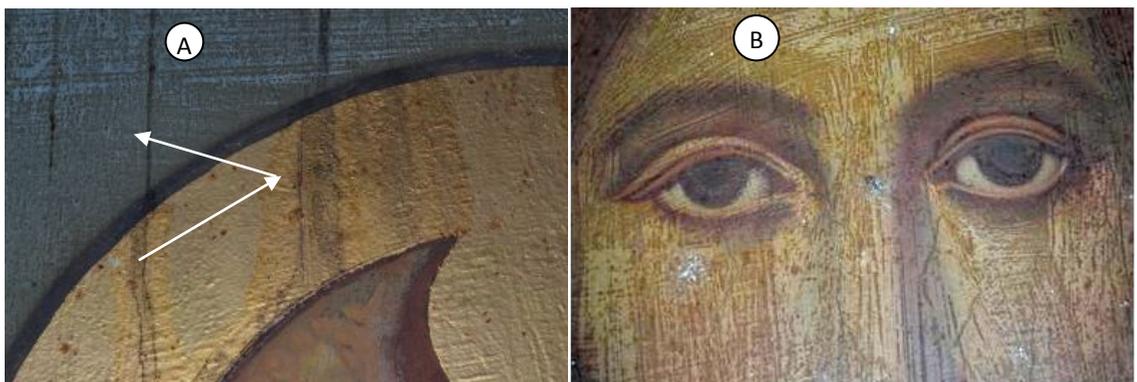
Figure7: Liquefaction of the paint layer at the other colors

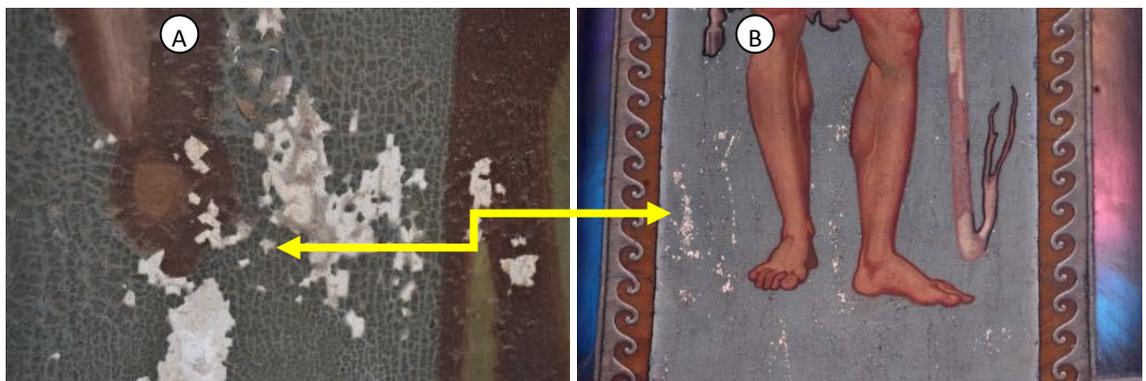
Figure 9a,b: scratches, which in several places had penetrated the intonaco layer

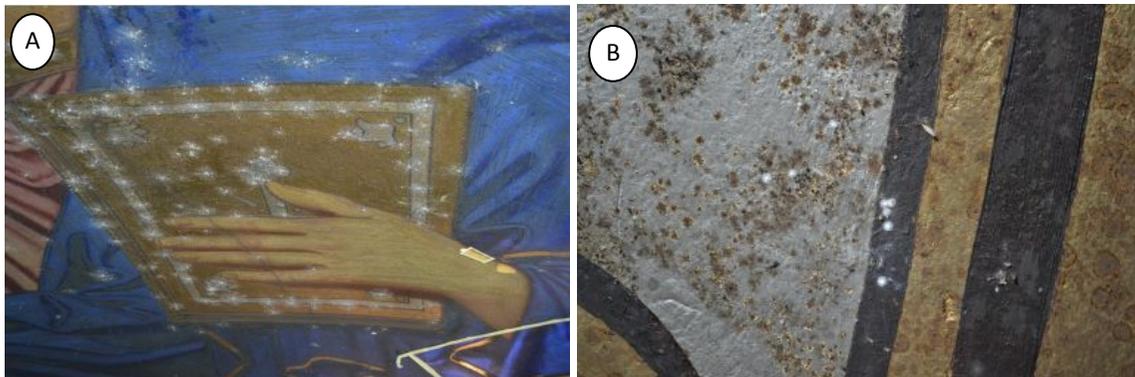
Figure 10a,b: Mildew discoloration at mural painting on St. George dome.

During the present investigation numerous fungal floras were identified that caused deterioration of the mural painting in the dome of the St. Gorge church. The results of the qualitative microbiological analysis of air samples for fungi are shown in (table 4). The fungal species *Aspergillus flavus*, *Aspergillus humus*, *Aspergillus niger*, *Aspergillus terreus*, *Alternaria alternate*, *Penicillium notatum*. A summary from around the world of the fungi found on mural painting to reveals many species in common. Biodeterioration problems in historic buildings and churches are well recognized and during the past few decades the role of the microbes in biodeterioration processes has been acknowledged (Saarela et al 2004). Growth of microorganisms on mural painting can result in visible aesthetic and structural damage. Some examples of visual damage on mural paintings at the dome are given in (fig.10a, b). On such substrates aesthetic damage implies pigment discoloration, stains and formation of a biofilm. Structural damage is observed as cracking and disintegration of the paint layer, formation of paint blisters, and degradation of varnish and binders resulting in detachment of paint layer from the support.

The immediate step was the biological treatment of the surface. A solution of Cedral (3%) was applied by brushing or spraying through Japanese paper. The areas affected by biological attack were monitored during the entire intervention.

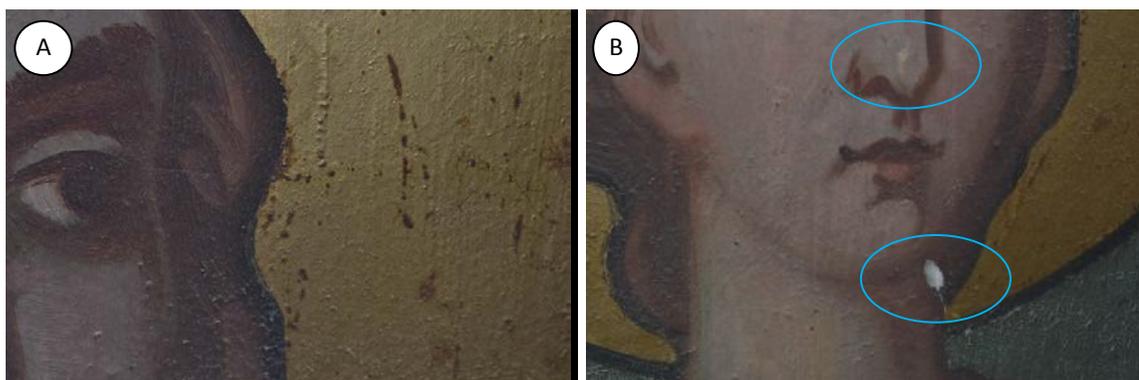
Figure 11a,b: organic materials at the surface of mural painting **a:** bat droppings **b:** extracts of birds

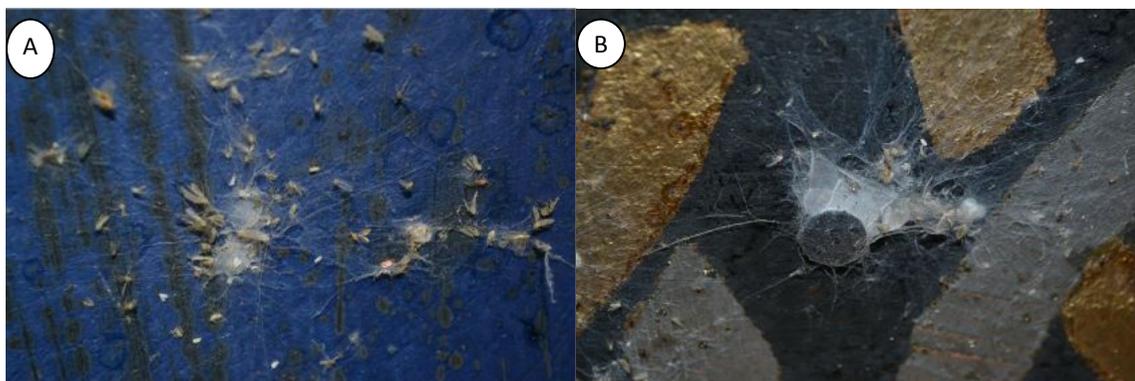
Figure 12a,d a, b Dirt, impurities stains, Insect broods and numerous cobweb nests on the painting's surface.

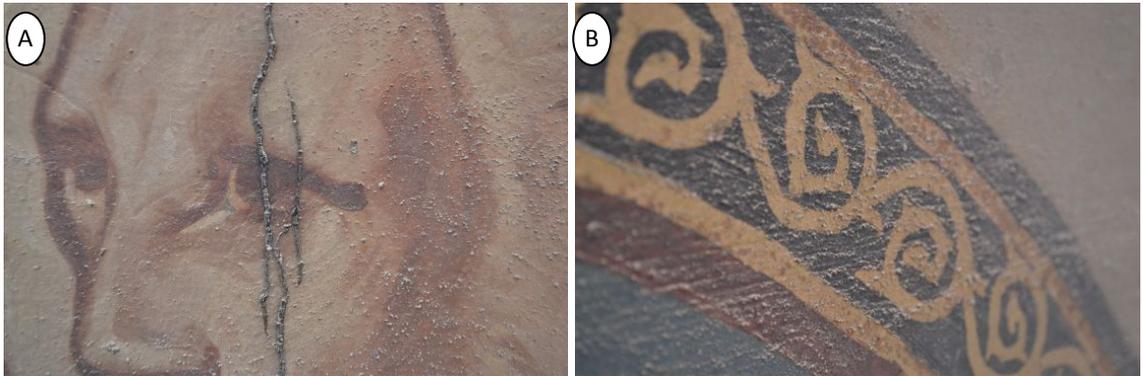
Figure 13a,b: due to the accumulation of airborne deposits from different sources on the surface.

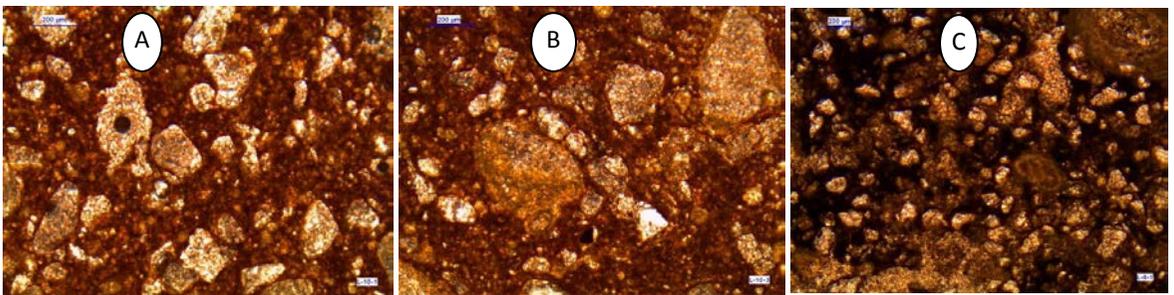
Moreover, presences of some gaps as a result of high porosity were noticed, (fig.16)

Figure16: optical microscope photograph of brick showing clay minerals, grain of quartz and iron oxide, also micro cracks, cavities and pits can be observed, 40-60x.

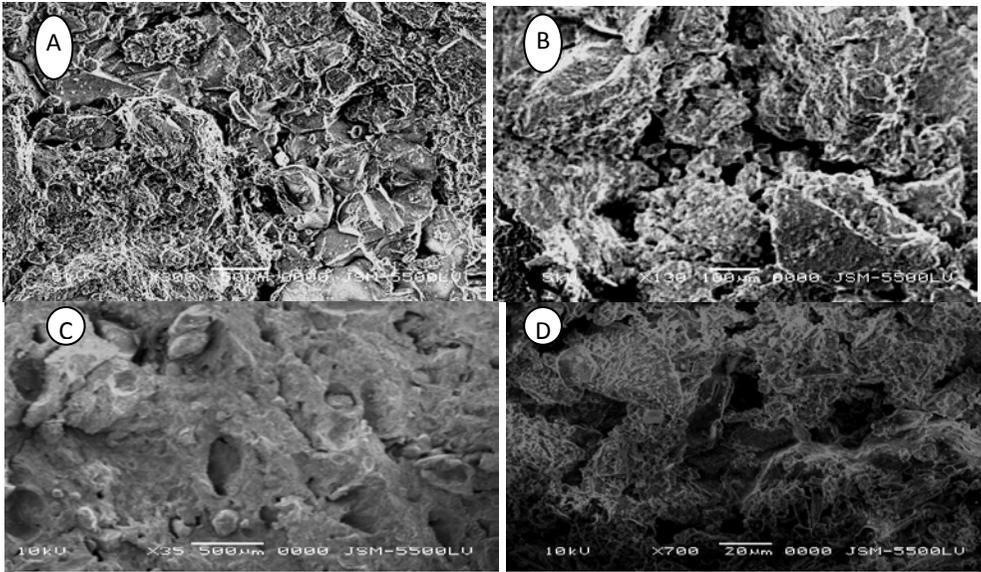
Figure 17: SEM photomicrographs showing the collapse of internal structure, voids, loose of binding material and salts crystallization between mineral grains.

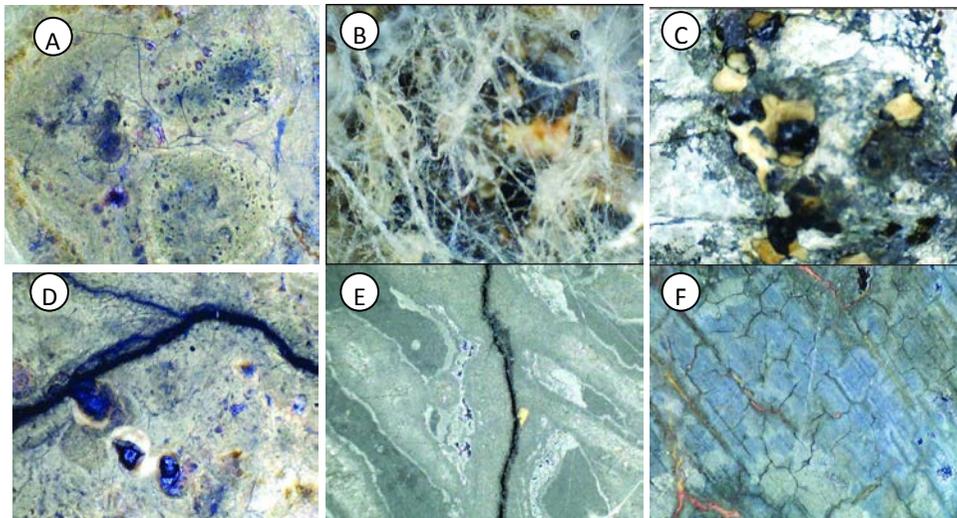
Optical microscope was used to inspect the different pigments (Fig.23) The LOM results shows the severe damage (disfiguring) of pigments, which are covered by a thick layer of dirties, LOM observation also revealed network of micro cracks.

Figure23a: f Optical Microscope investigation of pigments samples

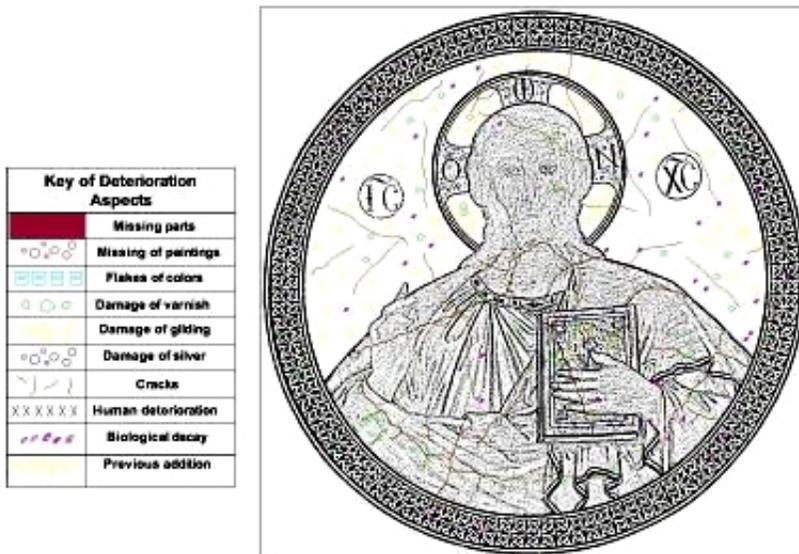
The conservation project described in the previous article had started in 2011 and is still ongoing. The project started with the research of the building condition and the conservation state of the walls and paintings. The causes of damage were identified and documentation drawings were made to map the different areas (fig. 25).

Figure 25: damage mapping documentation was prepared as a base for conservation interventions

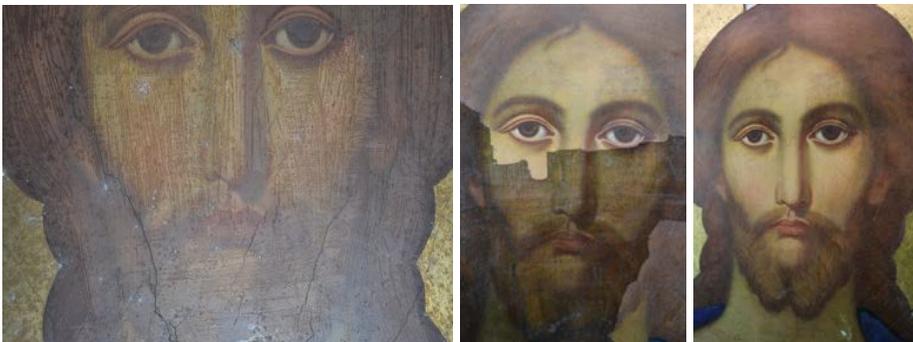
Figure 28: mural painting before, during after removing varnish layer.

According to above analysis, the mural paintings of St. George were carried out by oil painting technique, its surfaces was coated with varnish layer of dammar resin, the varnish layer was the original one and it was unique and no other coatings or additional layers were observed on the painted surface. The varnish layer was in an extremely terrible condition and thick with several physical damages such as severe scratches and detachments at discrete sites of the surface. In addition, it had an intense yellowish hue indicative of its oxidative and polymerized state. Apart from the damaged structure layers, the varnish was also affected. In addition, the existence of soot on the varnish layer proclaimed that it was slightly burnt, possibly from candles. The application of varnish layers has been shown to play a significant role in protecting painted surfaces (Stolow 1985). During aging, the varnish degrades through oxidation, auto-oxidation and crosslinking processes, catalyzed by the absorption of light (De La Rie1988). Owing to preservation reasons, the artwork must be relieved from the degraded varnish that can affect the inner layers (Theodorakopoulos & Zafiropulos 2003). Mechanical and chemical cleaning was used to remove the old degraded varnish. Scalpels were used for removing the thick parts of varnish layer as shown in (fig.28a). The solubility tests of the varnish layers were performed on the basis of finding the least concentration of solvent in an inert medium, which would marginally dissolve the residual varnish. For the particular mixture of the solvent system, a series of solutions of varying concentrations were prepared. Mixture of Isopropyl alcohol, Spirits of Turpentine and acetone (1:1:1) proved to be the most useful solvent for the old varnish layer which the mechanical cleaning failed to remove (fig. 28b).The chemical cleaning showed, that the varnish removal from all zones (fig.28c,29).

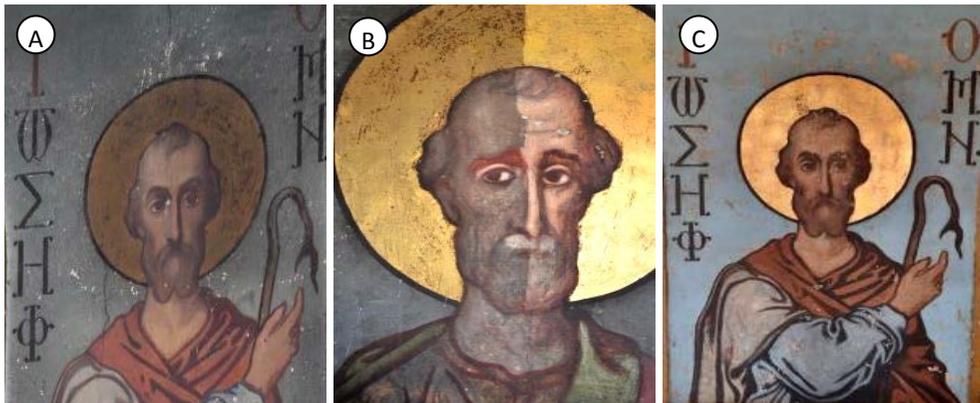
Figure 31: prophet No. 14 before, during and after cleaning.

The cleaning revealed the colorful original paintings and focused substantially on the removal of extraneous substances which were impossible to distinguish for so many years due to the dirty covering layers, soot and stains. A wide range of techniques is available for cleaning mural painting, ranging from mechanical cleaning to chemical cleaning. Considering the paint layer's sensitivity to water, we used mainly dry **mechanical methods** using cotton swabs, different types of brushes, scalpels and wishab sponges until the expected result was obtained(fig.29). We tried to improve the results of the dry mechanical method using in parallel chemical cleaning. **The chemical cleaning** was completed where necessary. Several solvent mixtures were tried but the best results were obtained with mixture of ethyl alcohol, acetone, toluene and trichloroethylene used for removal of dirt. Some initial tests were carried out prior to the intervention for setting up the right methodology specific for each color and gold layer (fig.29). It was applied two or more times, for very short periods, usually from two to four minutes. With this method, however, it was difficult to actually lift the dirt off the surface. A poulticing system was then tested. This consisted of small cotton-wool compresses, wetted with the same solvent mixture, placed on an intervention layer of Japanese tissue, and left in contact with the paint surface for ten seconds. Poulticing was repeated two to three times, if

necessary (Fig.29). This proved to be highly effective in removing the dirt and the coating without affecting the sensitive paint layer (fig.30, 31).

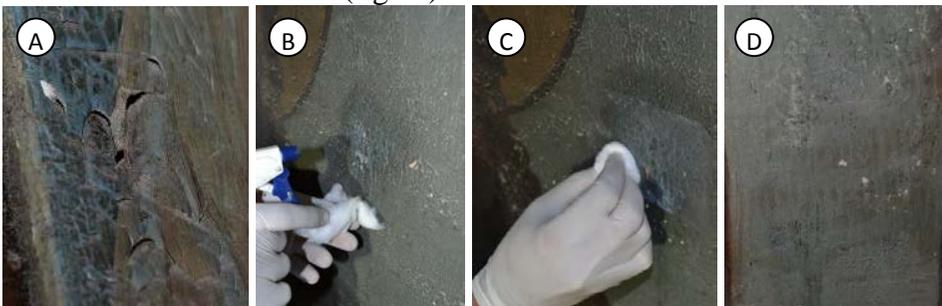
Figure 32: Fixation of the paint a: after b: fixative with B.72 c: the surface was pressed back into its original position using a protective sheet of silicon paper and cotton sheets d: the surface after fixation.

(fig.32c). Observing the behaviors of the surface after the treatment, sometimes the operation was repeated. Very good results were obtained with this method. In cases where fragments were almost completely detached from the support, a drop of Primal AC33 was placed at the center on the fragment and then the surface was laid down on the support by means of a spatula.

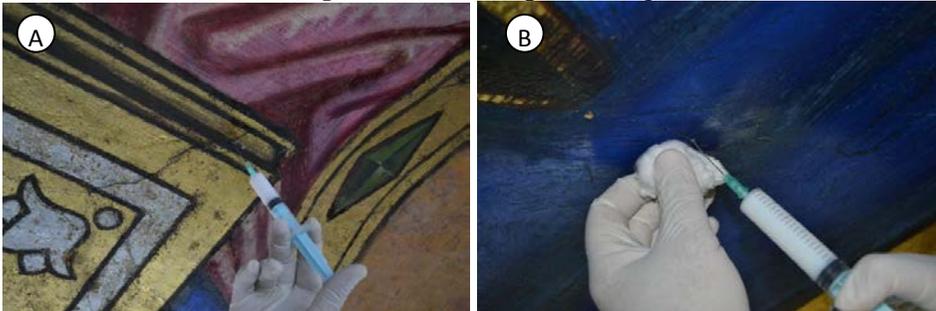
Figure33: injection process of cracks using Plexisol P 550

The mural painting at the St. George dome suffered from cracks of varying depth and width accompanied with loss of the parts of ground layer and some areas where the paint layer was detached together with parts from the preparation. The consolidation of the detached areas of the ground layer by injection was performed; using the Plexisol (Degalan) P 550. Plexisol P 550 is a 40% solution of an acrylic resin based on Butyl Methacrylate in

benzene 100°/140°C. It is used as a consolidant of ground and paint layer. It was appropriate to use due to both its better adhesive power and its capacity of creating a thin layer which could provide a better ground for pasting of thick layers. The very fine cracks that could represent outlets for the injected consolidant were temporarily secured by the application of white cotton and the detachment area was pressed with a spatula (fig33).

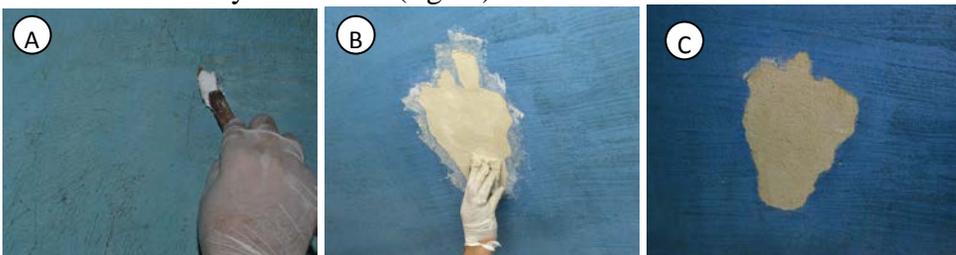
Figure34: filling gaps process a: filling lime mortar by spatula b: smoothed surface by sandpaper d: after filling

We proceed to the filling of the cracks and deep gaps of the ground layer. The fillings done using a lime mortar consisting of 2coarse sand + 1 lime + ½ zinc dissolved in primal AC33 1:8 with water. A coarse mortar was applied in in several layers so that it would evenly remain below the level of the paint layer. This surface difference allowed the ulterior application of a finer mortar layer. The fill material was applied by a spatula to flatten the putty and smooth and then the surface was smoothed by using different sizes of soft sandpaper to remove all products from the surface and prepared for the work necessary frills color (fig.34).

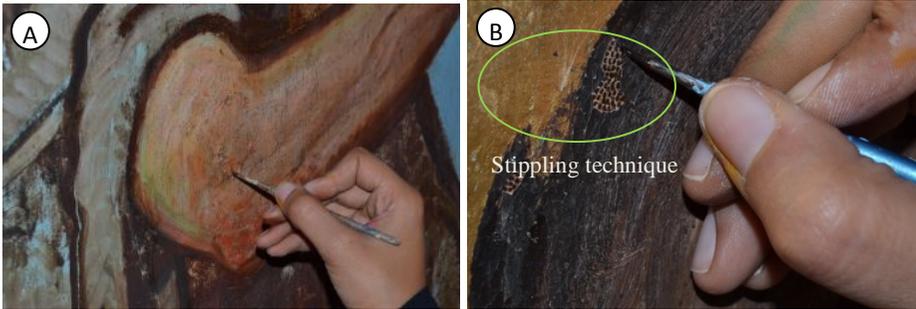
Figure35: Retouching treatment with stippling technique.

Most unsightly gaps were retouched by means of oil pigments applied in a stippling technique (fig 35). Oil colors were used for the whole retouching treatment due to their same type of original color and their resistance in time. Also linseed dry oil was used as binding medium. As a result, the white spots of the paint gaps were optically pushed backwards

leaving the original readable (fig.35). Gold paper was used to repair the gilded areas (fg.45).

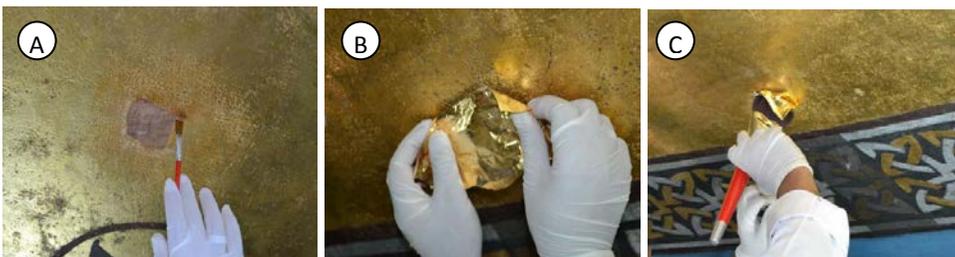
Figure36: Gold paper was used to repair gilded areas

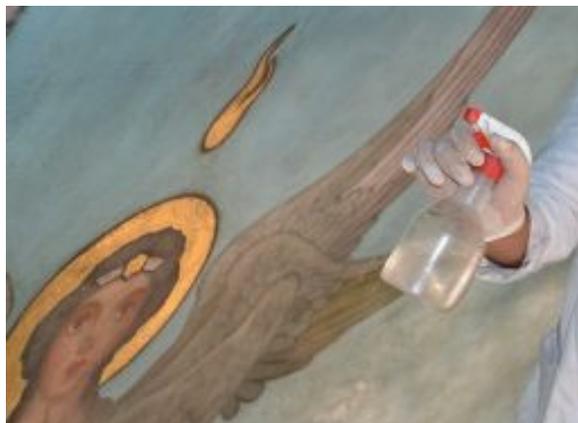
Figure36: final application of Paraloid B.72as new varnish.

There was final application to protect or saturate the painting. 3% solution of spray Paraloid B72 was applied onto the painted surfaces. These served as an isolating barrier to separate in painting and later protective varnishes from the original surfaces (fig.37). In addition, it consolidated areas that suffered from fine cracks and detachment parts. B72 was chosen for its well-known properties of reversibility and stability and thus allowing for its future removal. In addition to protecting from dust and dirt and this coating optically saturated the paint colors of both the original paint and the inpaint.
