THE DYNAMICS IN CHANNEL SHIFT OF THE BRAHMPUTRA ALONG THE AGYATHURI-SUALKUCHI AREA OF KAMRUP DISTRICT, ASSAM

Abstract

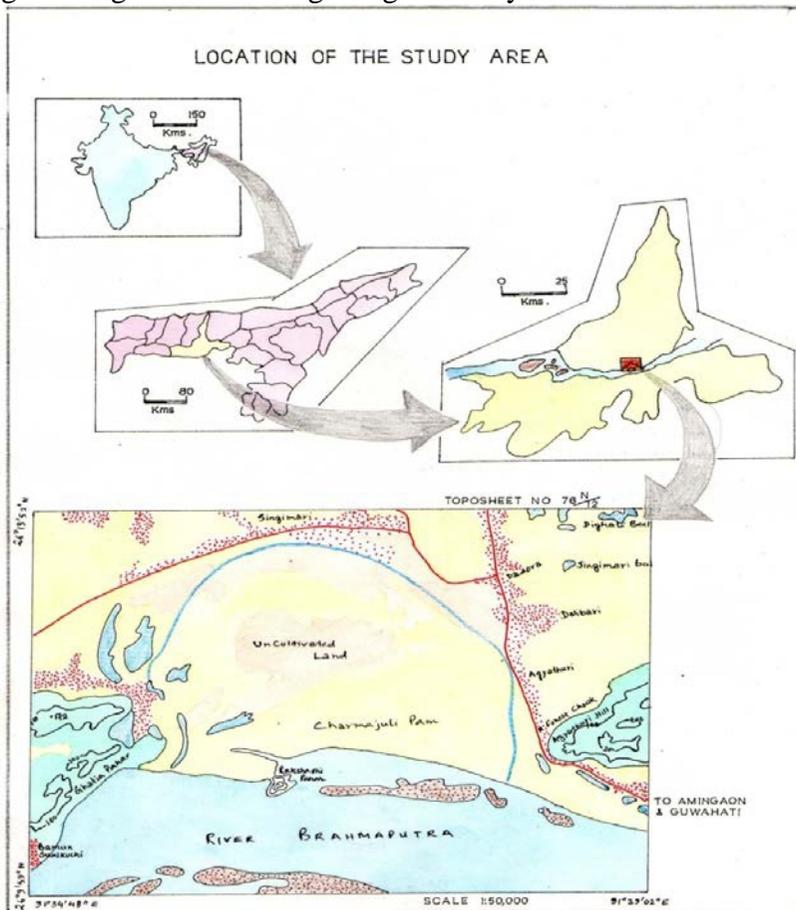
The study area i.e. Amingaon-Sualkuchi stretch from the Saraighat bridge to 5kms downstream, extends from roughly 91°30' to 91°40' East longitude and latitudinally it extends from 26°10' to 26°15' North. The area is surrounded by Agyathuri hills (387 m) in the East, Ghatia Pahar (172 m) in the West, Singimari-Sualkuchi road in the North and Sadillapur and Garigaon Hindu village in the south. The area has been chosen for study as the region shows interesting pattern of bank migration due to the controlling aspects of the Agyathuri and Ghatia Pahar in the east and west respectively. The northern flank being a plain tract and devoid of any natural or man-made obstacle is more susceptible to bank migration. Therefore the river is showing a strong northward migrating tendency here.

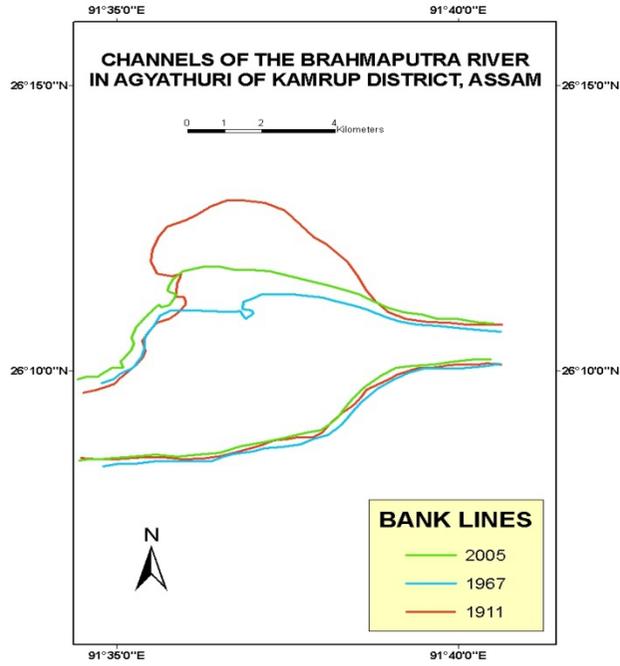
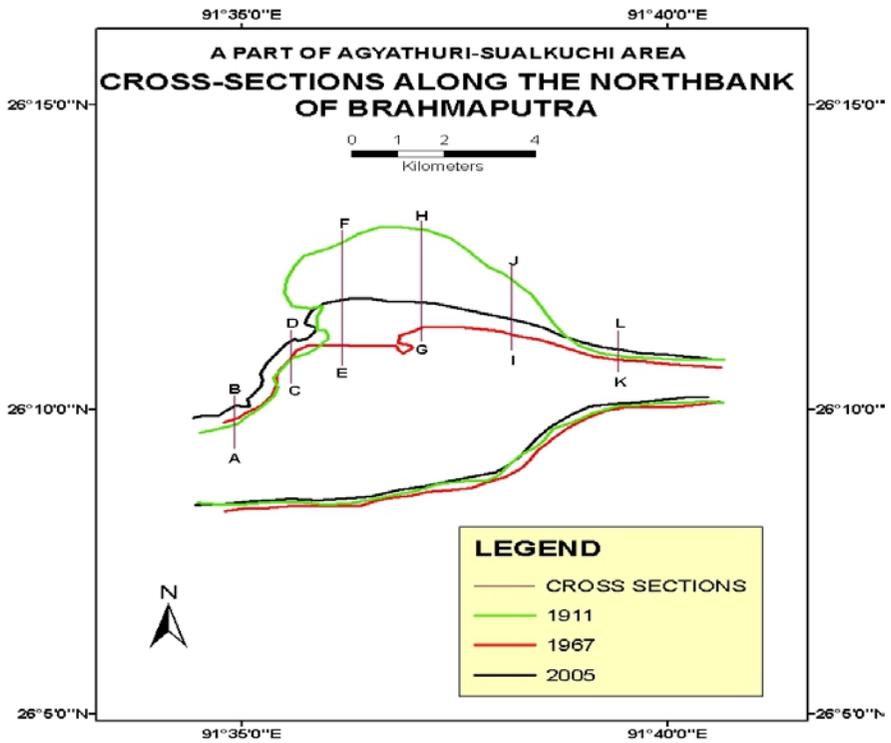
The extent of erosion in the proposed region has been measured at different cross-sections, from west to east along the north-bank of the Brahmaputra from Saraighat Bridge to 11kms downstream. A study of the Toposheets and Google images, pertaining to three different years (1911, 1967 and 2005) reveals that the north bank is highly unstable and is extremely susceptible to bank erosion. However in comparison to the north bank, the south bank is comparatively stable.

Table 1: Bank line Migration of the Brahmaputra along Agyathuri-Sualkuchi region, 1911-2005

<i>Cross-Section</i>	<i>Year</i>	<i>Bank line shift (in meters)</i>	<i>Direction of shift</i>	<i>Distance from Saraighat Bridge(in kms.)</i>
AB	1911-1967	210	South-North	11.0
	1911-2005	610	South-North	
	1967-2005	400	South-North	
CD	1911-1967	100	South-North	9.2
	1911-2005	610	South-North	
	1967-2005	510	South-North	
EF	1911-1967	3070	North-South	8.4
	1911-2005	1700	North-South	
	1967-2005	1370	South-North	
GH	1911-1967	3000	North-South	6.6
	1911-2005	2180	North-South	
	1967-2005	820	South-North	
IJ	1911-1967	1680	North-South	4.5
	1911-2005	1220	North-South	
	1967-2005	460	South-North	
KL	1911-1967	120	North-South	2.0
	1911-2005	210	South-North	
	1967-2005	340	South-North

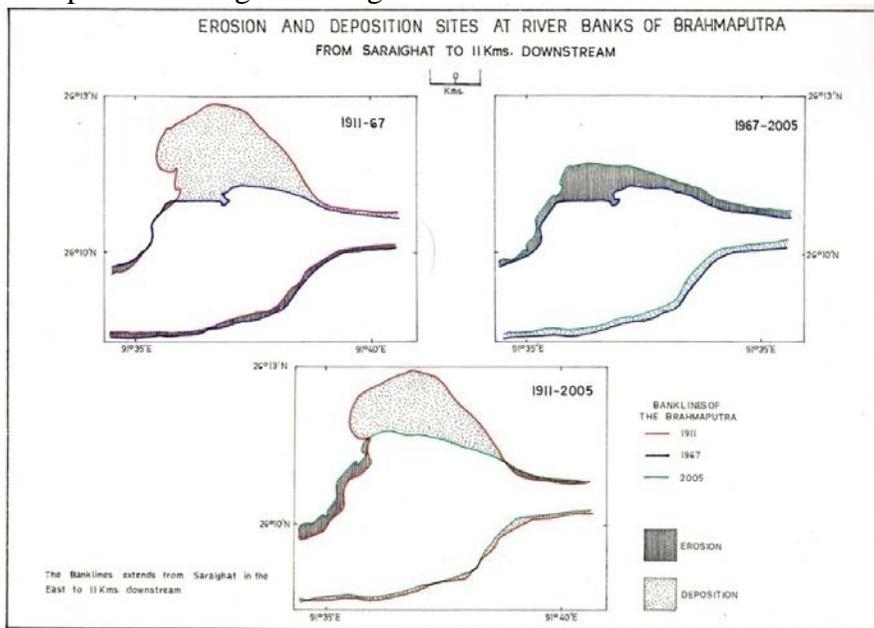
However where there is erosion, there exist deposition too. From 1911 to 2005, the deposited area along the north bank is 12.1sq.km whereas the south bank which is relatively stable experienced 3.2 sq.km of deposition. The stable nature of the south bank can be attributed to the bank protection measures that have been taken up on this side of the river (Ojha et.al, 2004). Anti-erosion measures like boulder pitching and land-spur have been adopted in the region during the mid 1970’s and 1980’s itself.

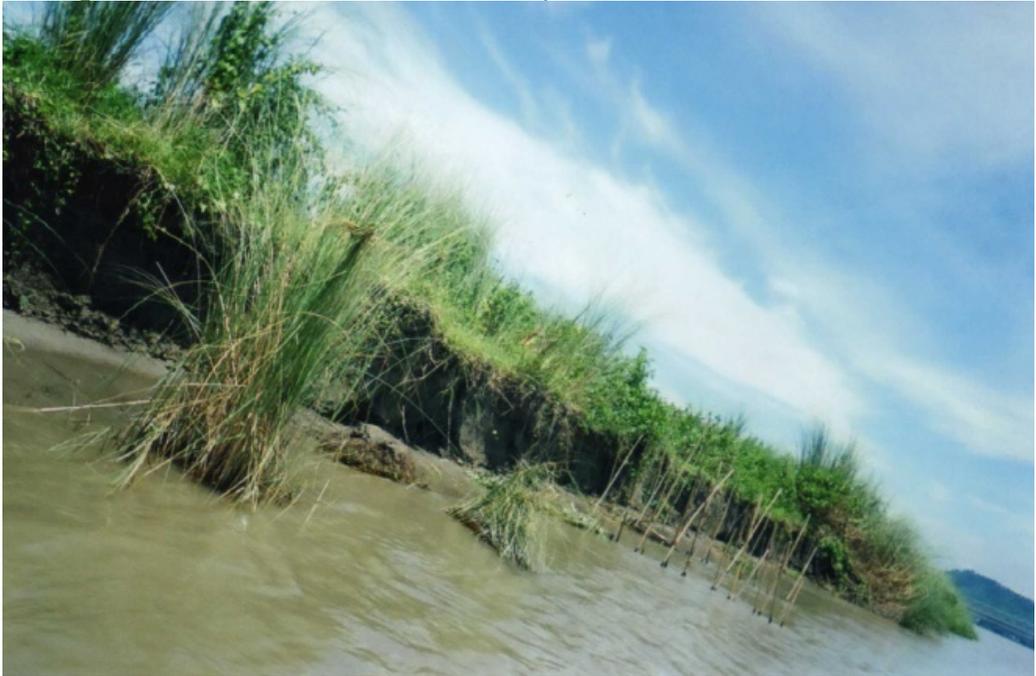
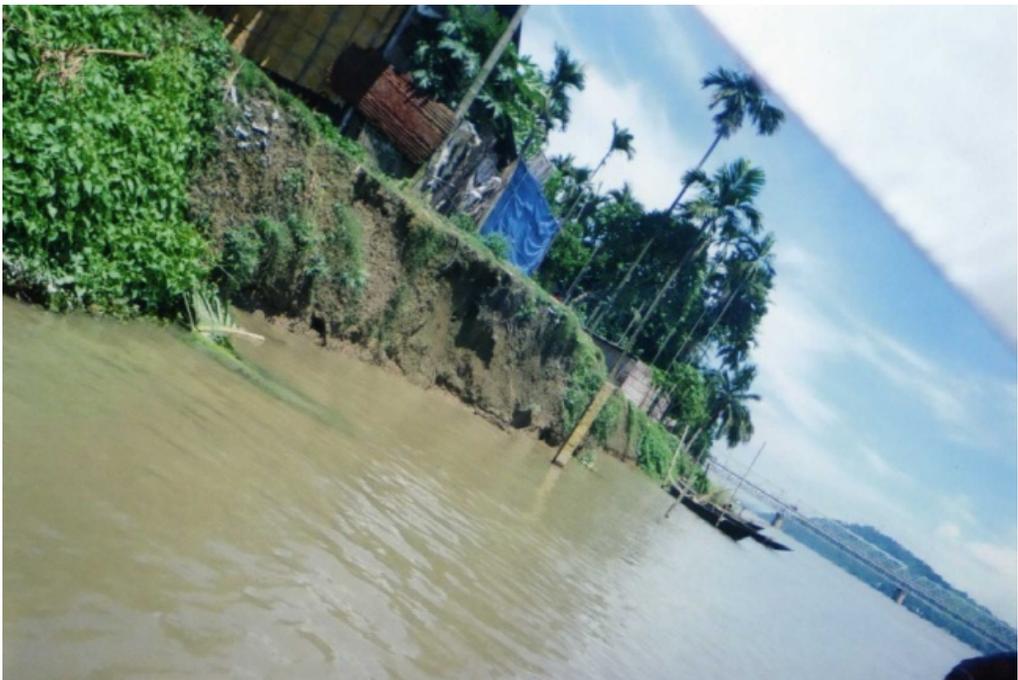
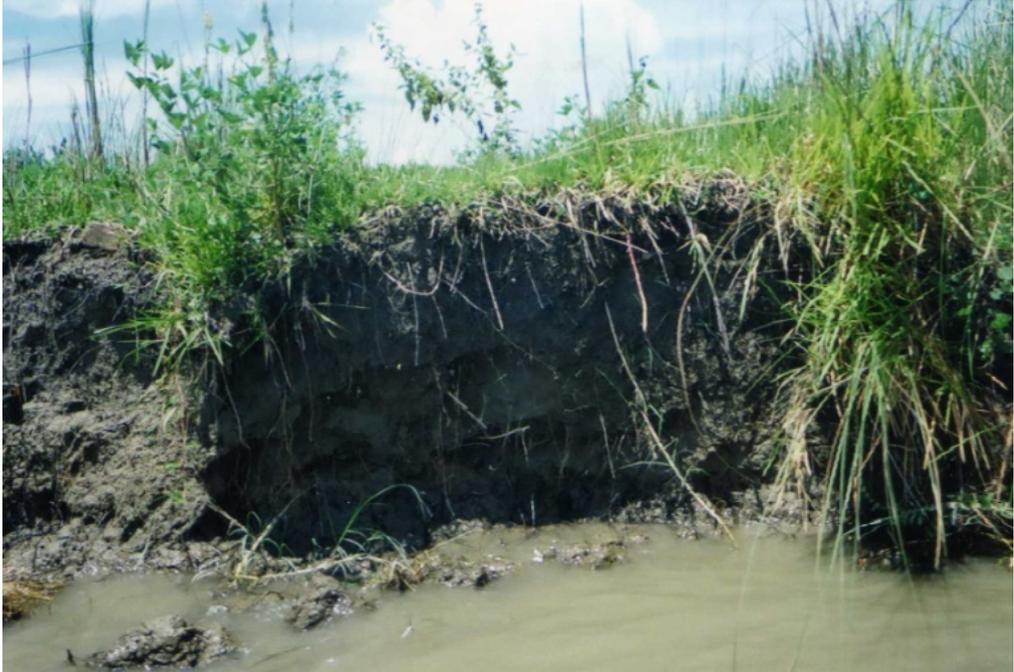
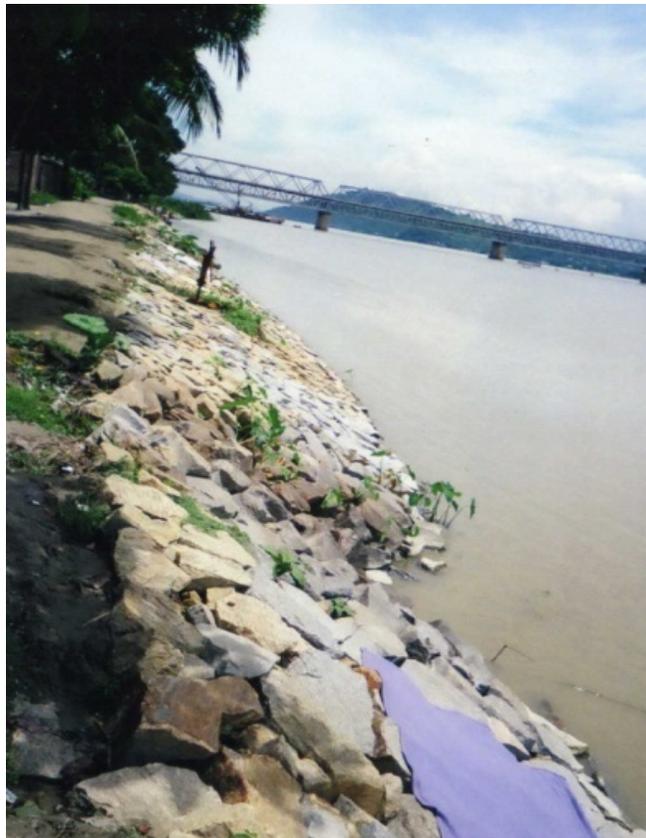
Some photos of bank erosion in the study area

Moreover with change in season, there is constant change in the level of water in the Brahmaputra due to which bank erosion starts. When the whole area is inundated by river water, erosion of the banks is minimum, whereas active erosion in the form of slumping dominates during the receding water level period (October-November)

In addition during low flow stage of the river, the underlying less cohesive soil of the bank gets eroded (toe-erosion) and as a consequence, the baseless bank collapses under the force of gravity.

Similarly earth cutting in winter season basically by the inhabitants of Choudhury village and its adjoining areas including lack of any artificial measures unlike the south bank are other important causes of bank line shift. The earth suppliers cut off the bank soil to cater to the needs of construction of the ever growing Guwahati city and thus render the region more exposed to erosion. Furthermore the lack of any artificial structural anti-erosional measures in the north bank aggravates the bank erosion and river migration.
