## EFFECT OF COASTAL ENVIRONMENT IN CLAY FACING BRICKS AND ROOF TILES

### Abstract:

Materials made from clay, such as bricks or roof tiles are widely used in recent buildings. Their severe exposure to salt spray, common in coastal environments could cause premature degradation which leads into functional, aesthetic, economical and safety problems.

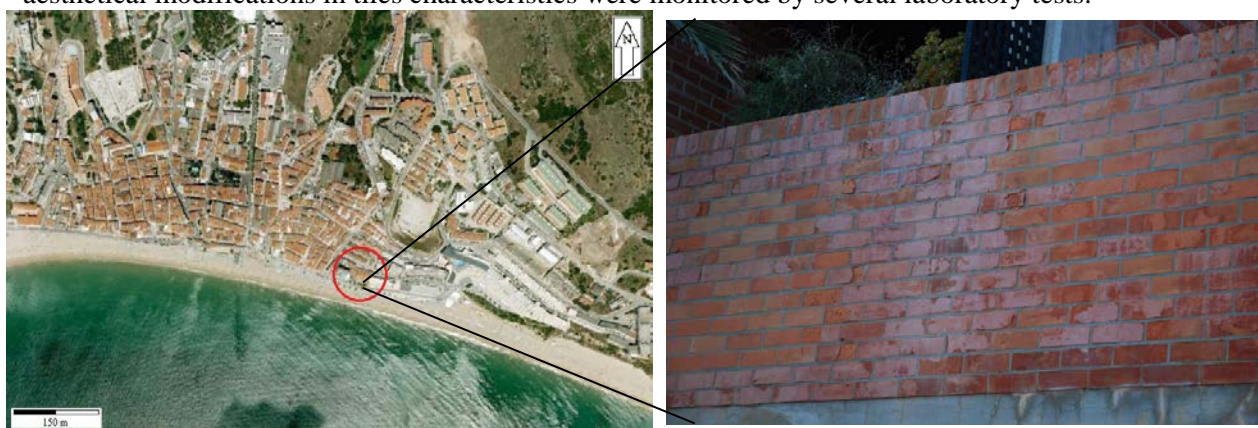
**Figure 1** - Aspects of clay bricks degradation due to sea spray action, Sesimbra, Portugal.

Therefore, it is obvious the interaction between the salt spray from sea and building materials, particularly in clay bricks and tiles. The degradation caused by this salt spray has been widely studied through short-term test in laboratory. Their effect is well known in several construction materials, e.g. in ornamental rocks (Galembeck *et al.*, 2008; Silva & Simão, 2009). Efflorescence resulting by salt deposits has been observed in old clay ceramic facades and results in harmful types of damaging like exfoliations or spalling (Kuchitsu *et al.*, 2000; Brocken & Hijland, 2004; Lubelli *et al.*, 2004). Due to severe exposure to sea spray, this type of degradation has also been found in several recent buildings. As an example, figure 1 show a photo taken in a building facade from a Portuguese coastal city (Sesimbra) a few years after its construction, where deterioration is clearly evident.

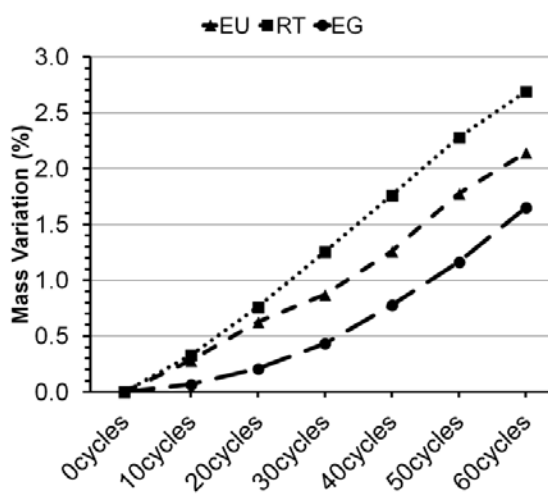
**Figure 4** - Evolution of cumulative samples weight (after wash).

Figure 4 exhibits the mass gain in the three materials after their immersion in distilled water. This emphasizes the difficult of fired clay materials desalination. The results may be explained by tiles distinct porosity characteristics (porometry, quantity, geometry and its connections to the exterior). These aspects can slow down the ingress of the distilled water and reduce the effectiveness of desalination.

Figure 3 and 4 represents the cumulative mass weight variations before and after samples washing, respectively. In general, it is possible to see higher values of mass variation for RT and smaller to EG. The higher or lower presence of salts within the porous structure, and the efflorescence on the surface, are reflected in the obtained mass values. This is an indication that the porosity must be greater in RT, smaller in EG and intermediate in EU.

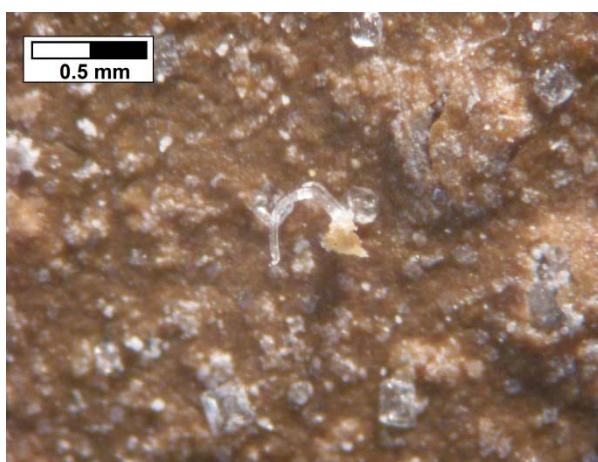
Through observation with the aid of a binocular microscope, other aspects may be identified. Before the desalination of the ceramics is possible identify different morphologies of NaCl salts on the surface. These different forms of crystallization have been already identified and studied (Arnold & Kueng, 1985; Arnold & Zehnder, 1985; Silva & Simão, 2009). The crystal habits are related to the type of material surface and the degree of solution saturation (Arnold & Zehnder, 1985). On RT surface, salt crusts, individual and well formed crystals and bristly efflorescences were identified. The two firsts morphologies are due to surface deposition of salts. In the case of the bristly efflorescences (some needlelike) it appears that crystals start their formation in the interior of the pores growing upwards to the surface. During this growth, the crystal applied stress into the surrounding material leading to their spalling and loss of material (figure 6).

**Figure 6** – Needlelike efflorescence causing spalling.

Crystals with such aspect were not present in EU and EG. Possibly due to its low porosity some of the salts and crystallization forms are trapped inside the less accessible pores however, superficial formation of individual crystals were detected.

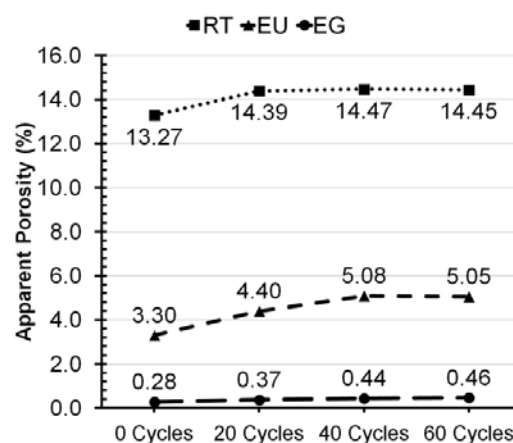
The values of apparent porosity in figure 9, can be relate with those described to water absorption. The evolution of the apparent porosity along the cycles was equivalent to the presented in figure 8 for water absorption.

Figure 9 – Apparent porosity evolution of the three materials.

The increasing values in these two properties are explained by the, already mentioned, action of NaCl crystals growth. This cause superficial material loss and internal micro-cracks, which produce additional available voids for more incoming water in water absorption test.

Comparing the differences between the initial and final values of the three materials, it is easily detected that the samples with lower initial value have a higher rate of changes. In the case of water absorption RT, EU and EG exhibit decreases of 10, 52 and 40%, when compared to the initial state. For apparent porosity these values are 9, 53, 54%, respectively. From this point of view, the lesser porous material showed a high rate of degradation. Thus, the rate of physical damage by salt crystallization is also function of other parameters, such as the moisture supersaturation, magnitude of the repulsive forces between the salts and the confining pore walls, rates of elements supply, water evaporation and the pore size (Scherer, 2004). A higher amount of salts within the material is not sufficient to cause more damage and appears that ceramic materials with smaller pore size (EU and EG) are more favorable to supersaturation and contact between pore walls.
