DIAGNOSTIC MONITORING FOR HISTORIC URBAN LANDSCAPE CASE STUDY: BUILDING IN VIA CARACCILO NAPOLI

The paper introduces as a case study, a nineteenth-century neighborhood in Naples, completed in 1869-80, with the reorganisation of the waterfront, filling the beach and constructing new buildings. The degradation reliefs, on sight and instrumental, carried out with the support of the infrared camera in three different moments of the building life cycle (2002, 2011, 2013), constitutes the knowledge base to relate degenerative phenomena with the constructive, morphological and dimensional characteristics and contextual conditions.

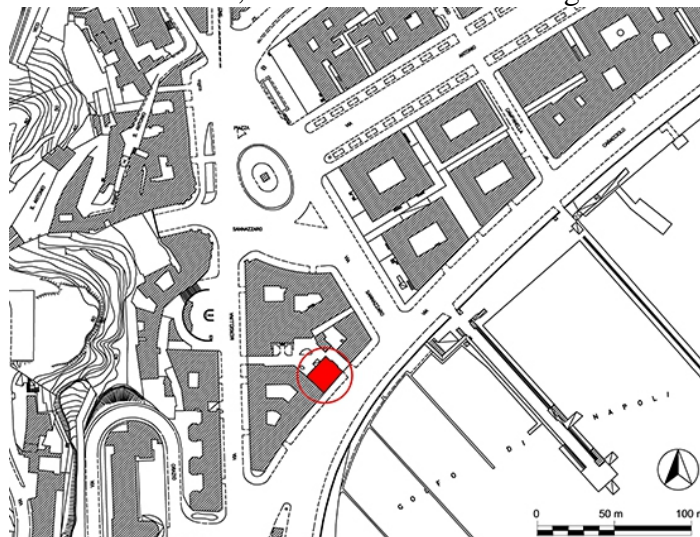
Image 1. Case study: nineteenth-century neighborhood

documents, manuals, designed to guide the interventions and controls⁴. The present section illustrates the iteration of the inspection activities carried out for the southeastern facade of the nineteenth-century neighborhood, located in Naples at the via Caracciolo, that is an arterial coast road with high-traffic density (Image 1). The research focused on external surfaces of perimeter walls through an "at sight" analysis. The front of the building is covered in smooth painted plaster for 18% of total solid surface - mq.37 on mq.210 for full surface -; it presents a rich stylistic array composed of:

- a basement in piperno slabs,
- string courses and crown, cantonal and surface of the first floor with covering in ashlar-work, pilasters with variable height, jutting out balconies with protective elements in marble and iron,
- at the fourth level, a veranda with iron and glass fixture.

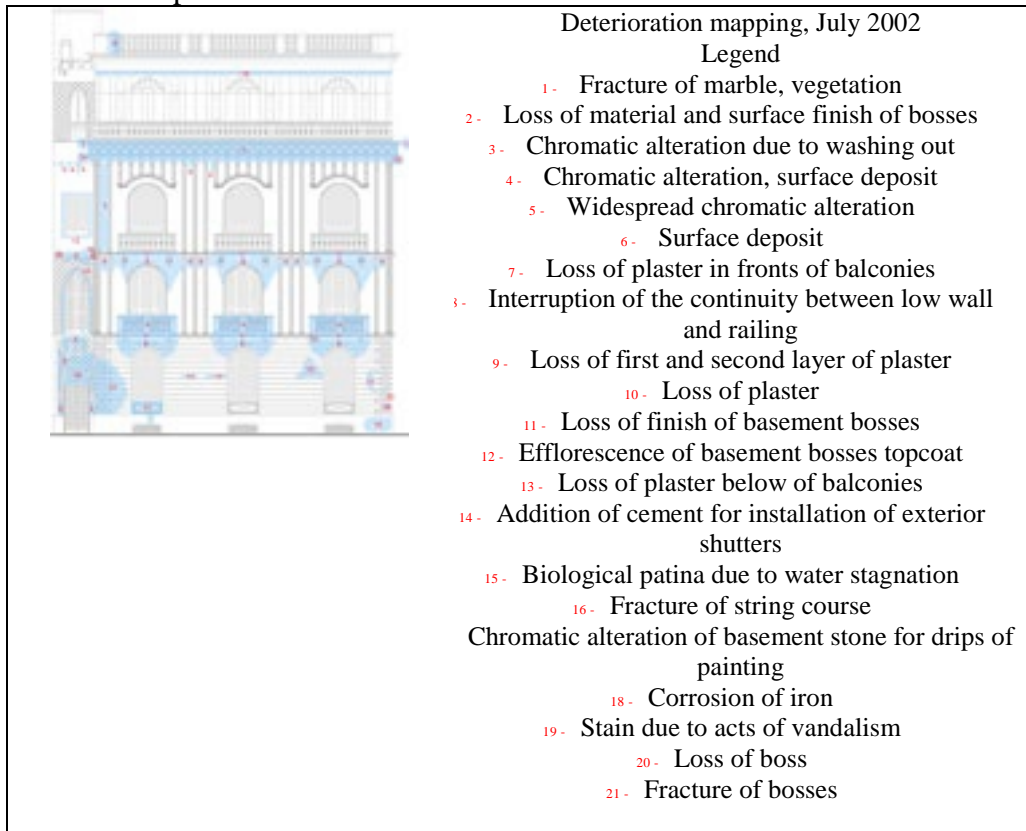
Image 3. The register of at sight controls

Faults mapping was carried out in 2002, 2011 and 2013; changes to the morphology and structure of the degraded areas have been highlighted thanks to a system of representation with monochrome graphics and numerical codification⁷ (image 3). Based on the first analysis, the following results are synthetically deducible:

- chromatic alteration in the left frame of the facade;
- extended surface deposit in two lower levels;
- loss of plaster in fronts and below of balconies;
- efflorescence in basement large area;
- corrosion of metallic elements.

- extended chromatic alteration due to washing out localized at the left of the facade, on the string courses and on basement;
- efflorescence on the left of the facade;
- surface deposit localized on the cantonal of the ground floor.

- expansion of areas with loss of plaster;
- chromatic alteration below of balconies;
- extended chromatic alteration on ashlar-work of first level.

Data acquired through surveys allow to formulate hypotheses about the causes of decay. According to consolidated practice, the validation of developed assumptions can be supported by results of an instrumental diagnosis project. In this case, the correlation between the observed symptoms, the characteristics of materials and contextual conditions allow to identify the main factors triggering and amplification of the degenerative processes of natural climatic factors, the morphology of the facade elements, air pollutants present and exposure to a marine atmosphere.

The erosive action of rain water is identified in areas that haven't been adequate elements of protection and draining, on the left of the façade; this decay is empowered by the shape of the compositional and stylistic elements - cornices and overhangs - that facilitate in part the water stagnation, like for the crowning cornice between the third and fourth level.

The proximity with the sea contributes toward the formation of saline deposits and efflorescence. The adjacency to an arterial road – via Caracciolo - exposes the coating materials to a constant polluting pressure; air pollution is an accelerator of degenerative processes, which may compromise the durability of materials, in the absence of maintenance operations.

The iterated observation of related and overlapping decays' effects suggests to graduate the inspecting action. Not considering the accidental events, experienced data support for the formulation of time scheduled controls. For example, with regards to plastered surfaces, it's appropriate to make a distinction between the coplanar areas of the front and the jutting out elements; on the base of time range defined by the scientific literature about building maintenance (Di Giulio R., 1999) specific contextualized controls

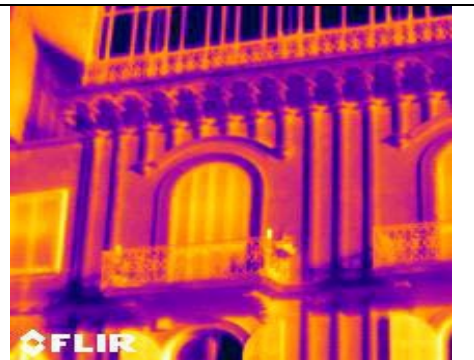
Image 4 a Chromatic alteration

- chromatic alteration for leaching localized in correspondence of the frame and the crowning of the fixtures (Fig.1a, 2a);
- surface deposit located in the basement (Fig. 3a) .

The results of diagnostic tests performed in 2011 showed widespread phenomena of chromatic alteration of the painting at the crown cornice as well as can be seen in Image 4; the thermogram shows the phenomenon of stormwater runoff in areas with strong differences in temperature (blue-green areas). The factors that cause deterioration of the disease, are attributable to the runoff of rainwater and the radiation constant. Another phenomenon observed is the deposit surface, very evident in the thermogram reported in figure 6; whole basement strip by a thermal response inhomogeneous, typical of this phenomenon.

The results of diagnostic tests performed in 2013 in addition to noting the evolution of the phenomena already present, as well as in the thermograms of Images 4 and 5, reveal the presence of spots under balconies, due to infiltrative phenomena . In Figure 6, shows the thermogram of balconies and show, in the vicinity of the support structure temperature differences (Δt), equal to 3 ° C between the coldest and the warmest area, clear symptom of leaks.
