THE ISSUE OF OBSERVANCE OF SAFE FOLLOWING DISTANCE BETWEEN VEHICLES IN GERMANY

Brno University of Technology/Institute of Forensic Engineering,
Czech Republic

Abstract

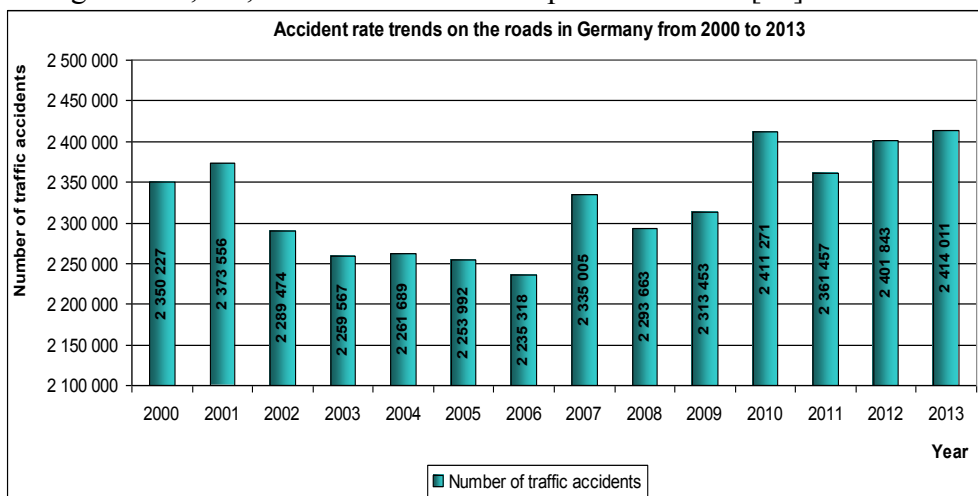
Graph 1: Accident rate trends on the roads s in Germany from 2000 to 2013 [11]

According to UNECE statistical data, there occurred a total of 32,554,526 traffic accidents on the roads in Germany from 2000 to 2013 (see the following chart), which represents an average of 2,325,323 traffic accidents per year. [11]

From 2001 to 2006, there was a significant drop in the number of these accidents, namely to 2,235,318 accidents. The significant decrease by more than a half could have been influenced by amendments to legislation and a number of factors, which included, for example, developing active and passive vehicle safety, increasing transport infrastructure safety, campaigns focused on increasing prevention in the field of road safety, innovations concerning driver education, increasing the number of road checks etc. By contrast, from 2007 to 2013, the number of traffic accidents increased on average with 2,414,011 traffic accidents reported in 2013. [11]

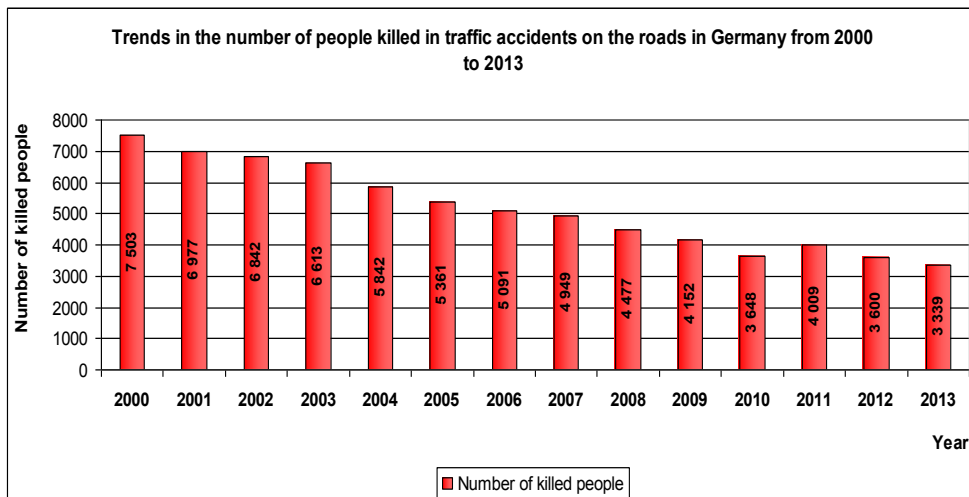
Graph 2: Trends in the number of people killed in traffic accidents on the roads in Germany from 2000 to 2013 [11]

According to UNECE statistical data, the number of people killed in traffic accidents on the roads in Germany gradually decreased from 2000 to 2013 (see the following chart). In 2013, the number of people killed reached approximately 45% of the figure of 2000, namely with 3,339 people killed. A person is considered killed in a traffic accident if they died as a result of a traffic accident within 30 days. [11]

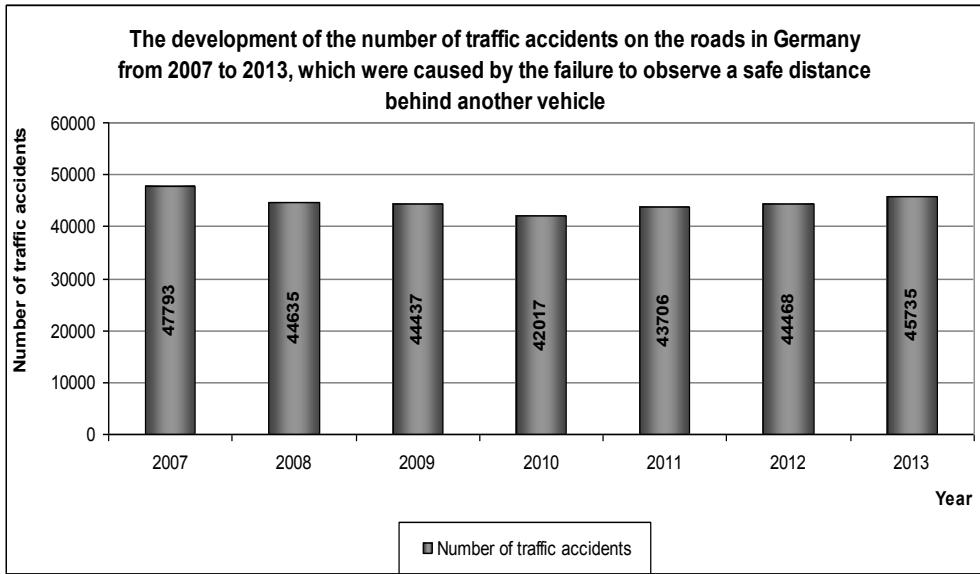
Graph 3: The development of the number of traffic accidents on the roads in Germany from 2007 to 2013, which were caused by the failure to observe a safe distance behind another vehicle [3,4]

The following chart shows the development of the number of traffic accidents on the roads in Germany from 2007 to 2013, which were caused by the failure to observe a safe distance behind another vehicle with the cause being related to traffic accidents, which resulted in injury or death.

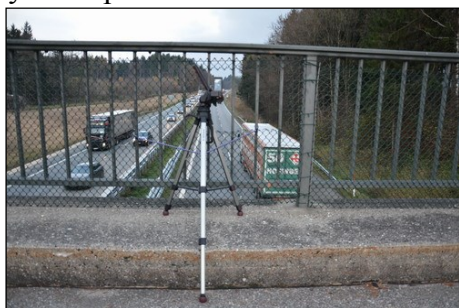
Fig. 1: Camcorder station - measuring near the village of Winkl

Measurements were carried out in Germany. The first speed measurements were carried out on the A8 motorway with two traffic lanes per carriageway, in particular in the vicinity of Exit No. 109, in the direction of Salzburg, near the village of Winkl. Next, speed measurements were carried out on the A9 motorway with three traffic lanes per carriageway, in particular in the vicinity of Exit No. 64, in the direction of Nuremberg, near the village of Au A. Aign.

All measurements were made under relatively fine weather conditions and in good visibility. When recording, the camcorder was hidden from the drivers’ sight so as to pass unnoticed and not to affect their behaviour. Video recordings were taken using a digital camcorder with 1920 by 1080 pixel-resolution with 50 frames per second.

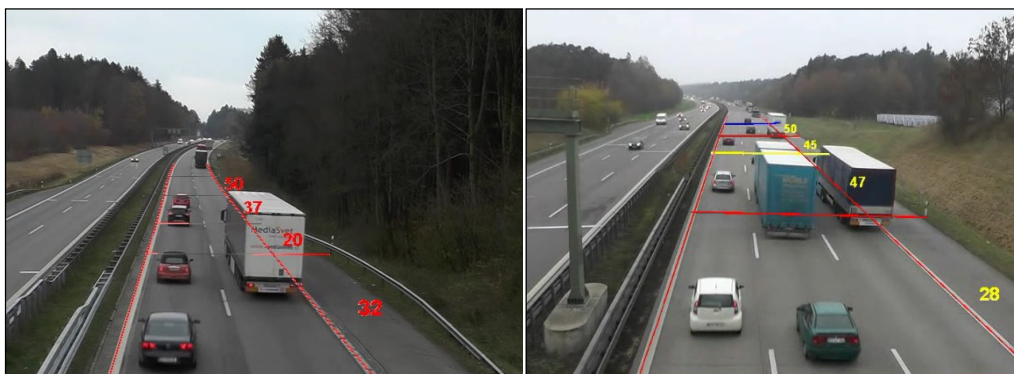
Fig. 5 The A8 motorway near Winkl, 114 km/h, 9 m (0.28 s)

Fig. 6 The A9 motorway near Au A. Aign, 100 km/h, 13 m (0.46 s)

Many of the monitored vehicle drivers failed to observe a safe distance, which, for example, should be approximately 72 m at 130 km/h (in the case of the so-called “two-second rule”). Some drivers even got near the vehicle in front of them up to a distance in the order of individual metres, as can be seen in the following pictures. At 130 km/h, a vehicle will cover the distance of 10 m in about 0.28 s, which is well below the mean value of the driver’s standard reaction time.

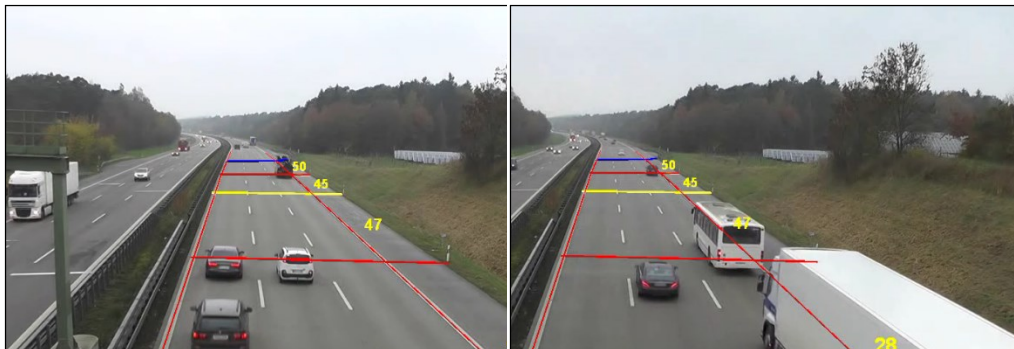
Fig. 7 The A9 motorway near Au A. Aign, 152 km/h, 8 m (0.20 s)

Fig. 8 The A9 motorway near Au A. Aign, 86 km/h, 13 m (0.54 s)

In some cases, dangerous reduction of the following distance between vehicles could be observed, when a vehicle suddenly moved in front of another vehicle when overtaking.
