CONSERVATION OF THE MURAL PAINTINGS OF THE GREEK ORTHODOX CHURCH DOME OF SAINT GEORGE, OLD CAIRO-EGYPT

Abstract

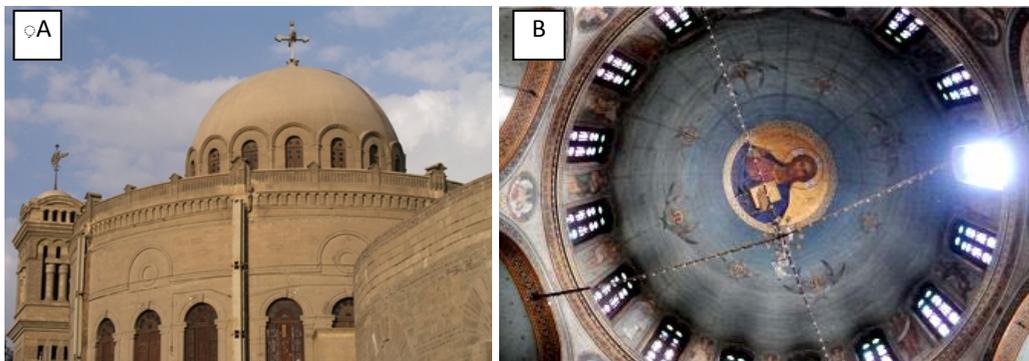
Figure 1: The Church of St. George in old Cairo: a: outside view of the church dome b: inside view of the dome

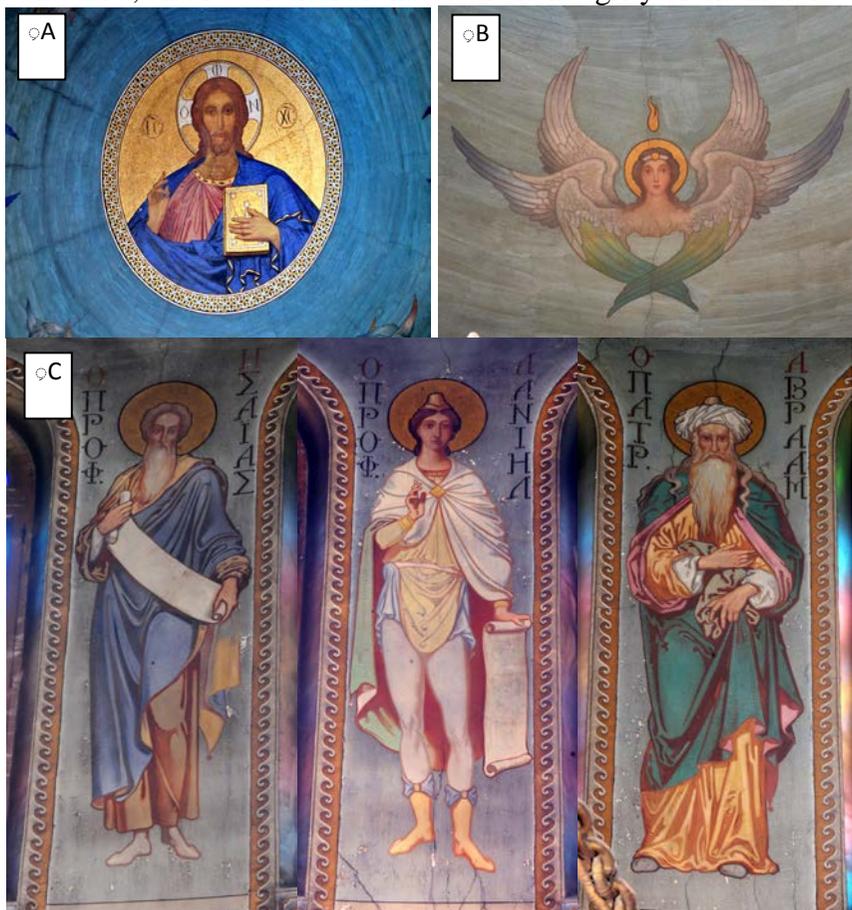
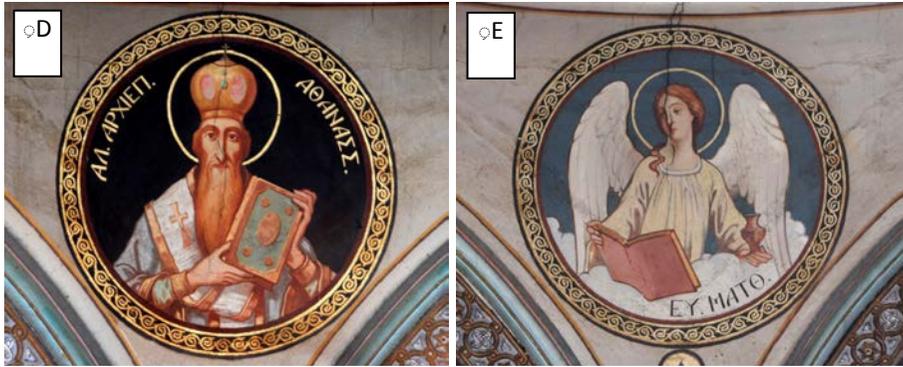
Figure2: the mural painting at the St. George Church dome a: Paintings of the Christ b: Paintings of the Angels around Christ c: Paintings of the full-length portraits for of prophets in the barrel of the dome d, e: Pendentive.

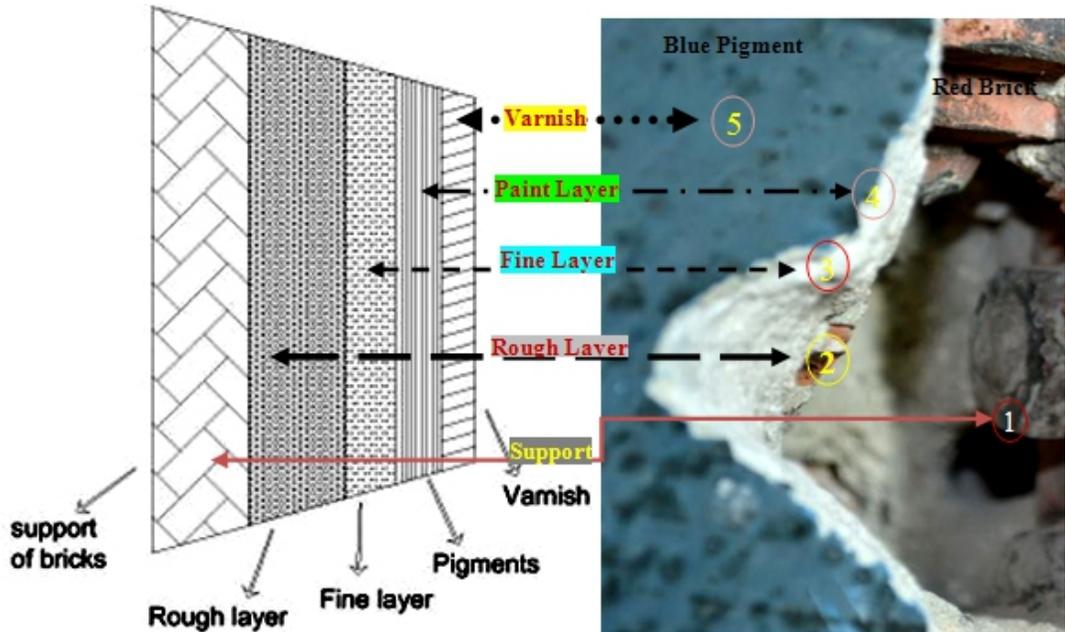
Fig.4 the mural painting structure layer a: plane of painting structure layer
 b: detail from area of loss on dome

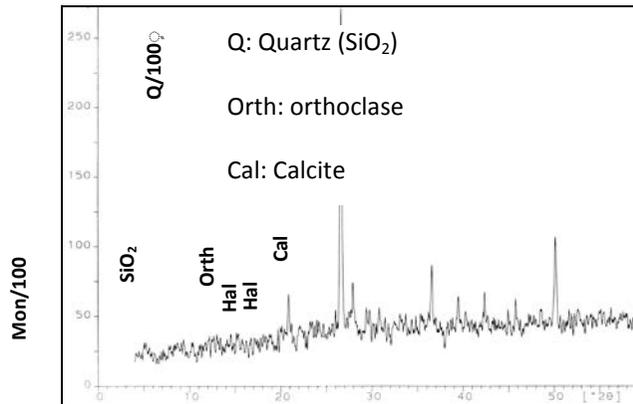
Mineralogical compositions of brick were determined by X-ray diffraction (XRD) (fig.14) indicated that they were mainly consists of quartz (SiO₂), Orthoclase (KAlSi₃O₈), Silicone oxide (SiO₂), Calcite (CaCO₃) in addition to halite (sodium chloride), iron oxide (Hematite Fe₂O₃) and clay minerals. Their elemental composition analysis carried by SEM-EDS revealed it was consisted of high amounts of Quartz (37.82), Aluminum (Al) (17.30), Calcium (Ca) (13.43), iron (Fe) (9.7), magnesium (Mg) (7.27) and minor amounts of K (3.43) and Ti (1.11) (fig. 15). Considering the above results, it can be claimed that the brick consisting of high amounts of Quartz, Clay minerals, Calcite and iron oxide. These results confirmed the XRD results. SEM and Optical microscope observation of bricks shows that there are some cracks, gaps and voids, which led to the disintegration, separation, thus erosion and weakness of the brick internal structure. Also, dissolving of some brick components and crystallizing some types of salts were detected (fig.16, 17). Petrographic study of bricks shows that it consists mainly of clay minerals and quartz, in addition to a percentage of iron oxides.

Figure14: XRD pattern of redbrick samples

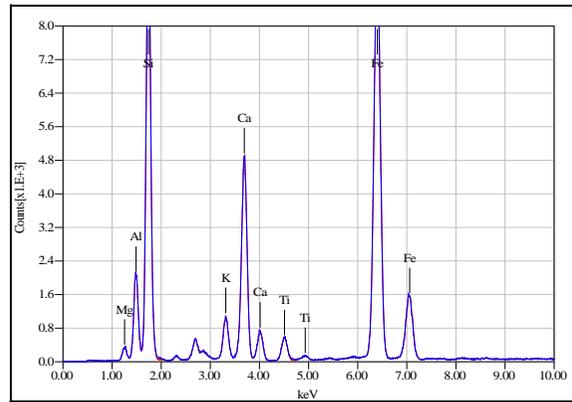
Figure15: EDX pattern of redbrick samples

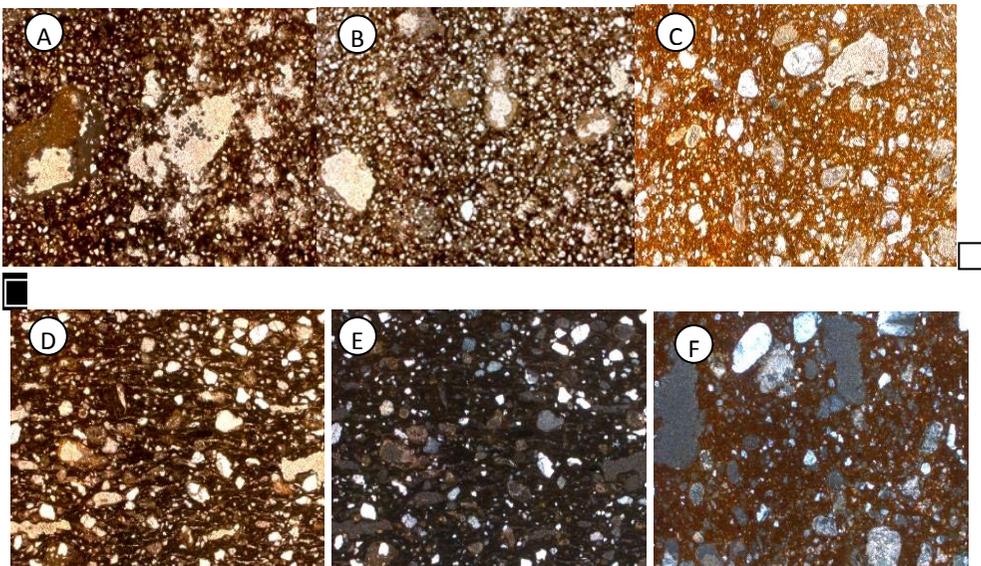
Figure 18: thin sections photomicrographs of bricks showing quartz grains, iron oxides, clay minerals and crystals of orthoclase 64 X.

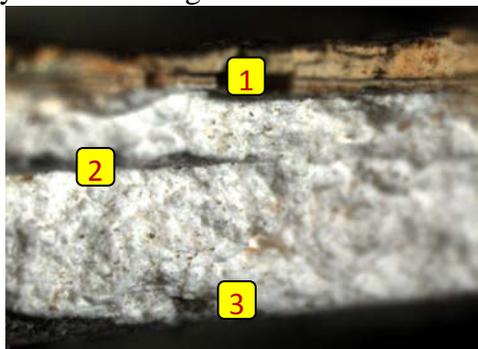
Microscopical observation of cross section of paint plasters in St. George Church, (fig.19) shows the painted layer approximately 5m thin and was applied in two underlying layers of plaster with micritic texture. The inner (bottom) layer which was applied over the wall structure is rough (arriccio) and second layer (upper) over this layer is finely smooth

Figure19: LOM photograph of cross section stratigraphy of painted layer

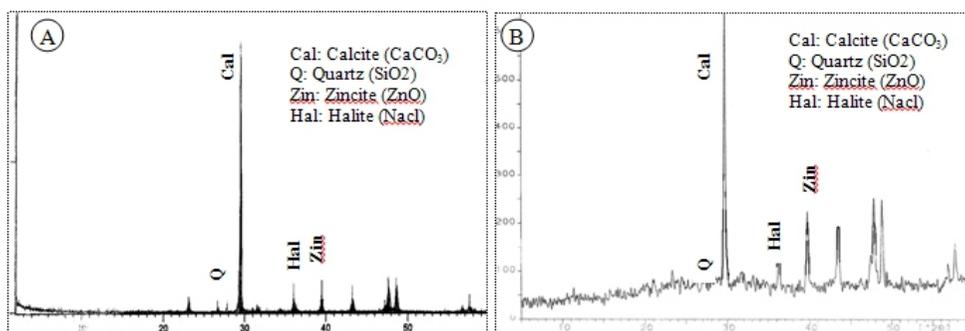
(intonaco). Mineralogical composition of plaster layers were determined by X-ray diffraction (XRD). XRD patterns of the rough plaster (figure20a) indicated that it was mainly consists of calcite, quartz, zincite and halite. Calcite is originated from lime and quartz from aggregates, zinc oxide from zinc and halite from salts, while the fine plaster layer (fig.20b) was composed of calcite, bigger ratio of zinc and low ratio of quartz than the rough samples. It is elemental composition analysis carried by SEM-EDS revealed that it was consisted of high amounts of carbon (c), calcium (Ca), zinc (Zn), aluminum (Al) and magnesium (Mg) (fig.21). Considering the above results, it can be claimed that fine plaster layers were prepared by using lime containing magnesium hydroxide as binder, zinc and sand as a filler. Sodium is found as halite NaCl whose presence is due to materials used in the ground layer or salty water which leaked through the ceiling and the wall. The high percentage of Carbon and Oxygen are mainly originated by the use of vegetable oil.

Figure20: XRD patterns of ground layer a: pattern of coarse ground layer b: pattern of fine preparation layer.

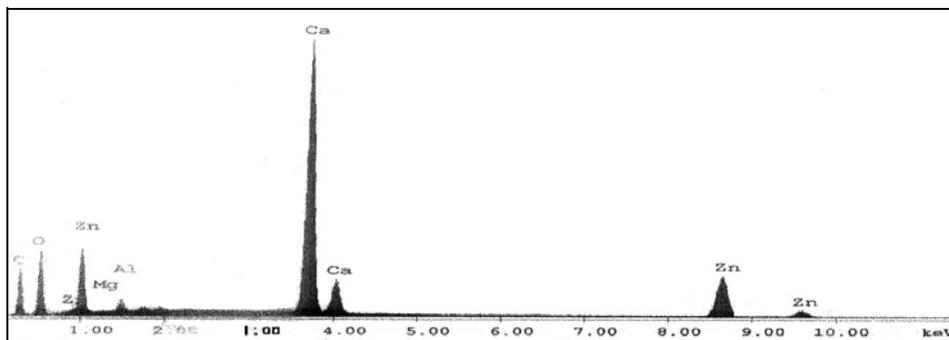
Figure 21 SEM-EDX spectrum of ground layer

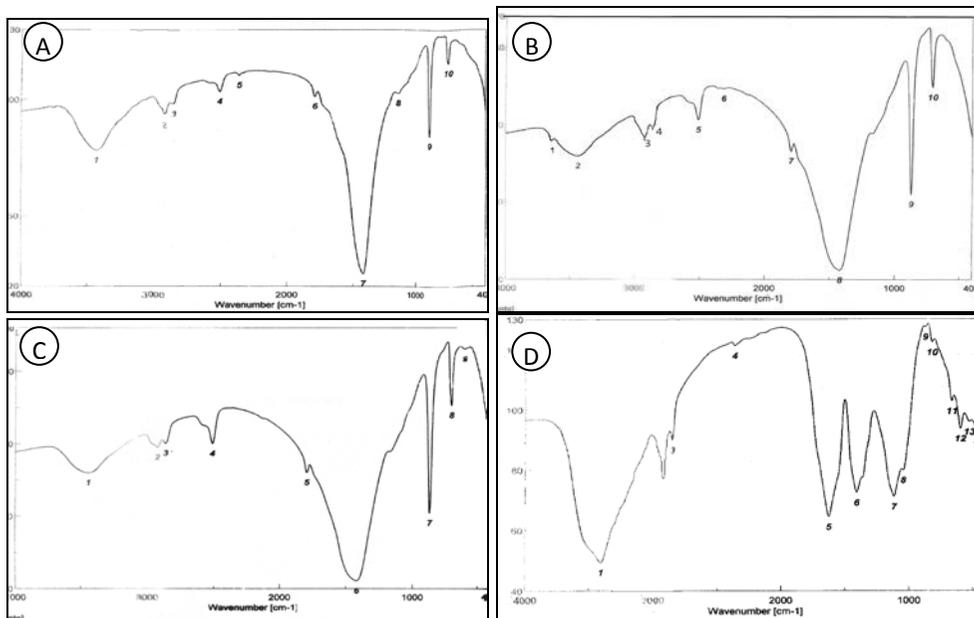
Analysis of the varnish layer by FT-IR spectroscopy showed that the varnish is Dammar (natural resin) that proved through comparing with new resin (fig.22d & table2). Dammar resin is a natural resin obtained from the *Dipterocarpaceae* family of trees in India and East Asia The soft, viscous, highly aromatic resin oozes readily from incisions in the bark and dries to become transparent, brittle, odorless lumps that are sorted into the following grades: pale (A), yellow (B), amber (C), and dust (Scalalone et al 2005).

Figure 22: FTIR spectra paint layer of St. George church dome A: blue pigment B: silver pigment C: gilded layer. D: Varnish layer.

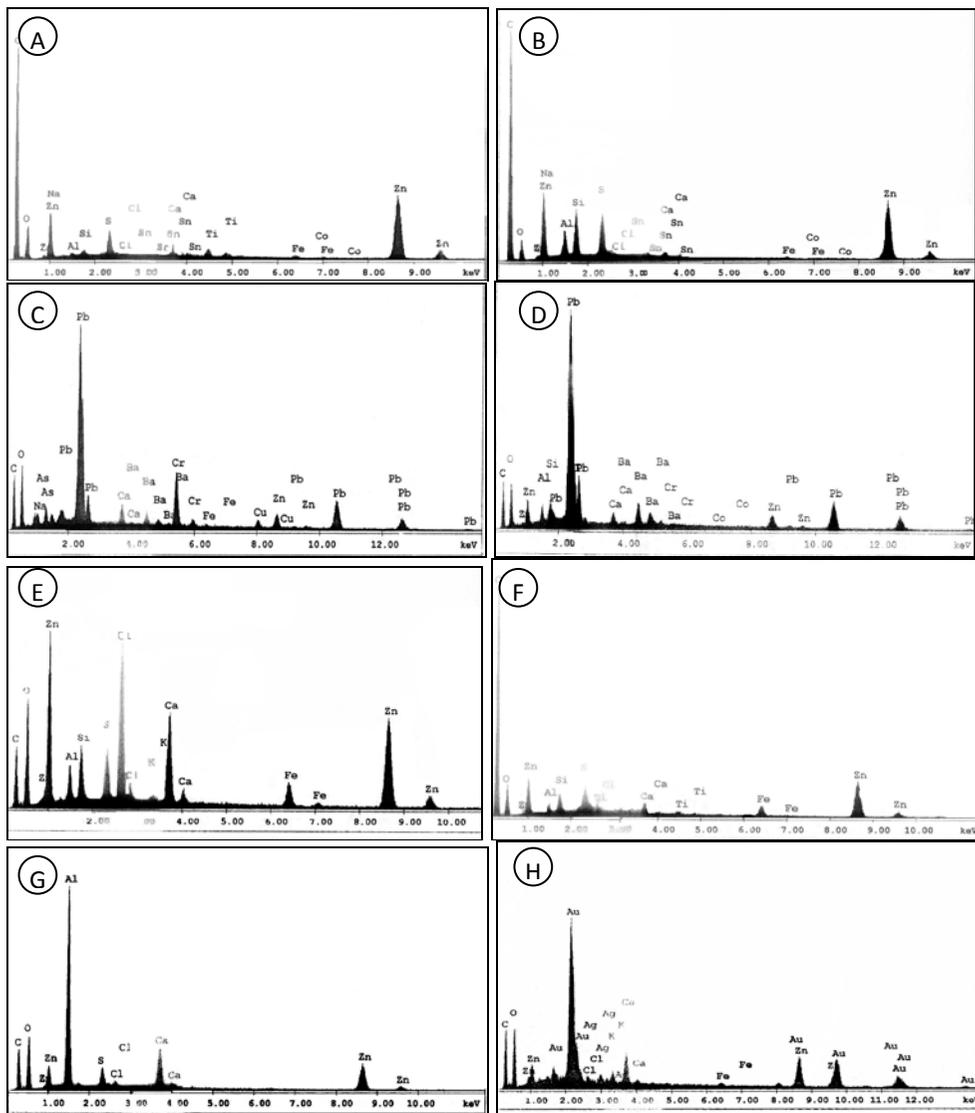
The **Dark blue** pigment sample has been collected from Christ clothes. In the EDX analyses of the dark blue pigment (Fig.24a) the presence of Na, Al, Si, S, C and Zn were detected, this leads to characterize the blue color as blue pigment consists of sodium aluminum sulfide silicate, ultramarine blue, $\text{Na}_8(\text{S}_2)(\text{Al}_6\text{Si}_6\text{O}_{24})$. The pigment ultramarine can be prepared from a natural semiprecious stone, lapis lazuli. The pigment is composed of silicon, aluminum, sodium, sulfur, and oxygen (Edwards et al 1997). Zn related to zincite and Ca related to calcite, so the presence of zincite and calcite are related to preparation layer. The presence of cl is related to Halite salt.

Light blue pigment sample has been collected from the ground around the Christ. It represents one of the few blue painted areas which have been mentioned by archaeologists. However, no chemical element imputable to blue pigments been detected with EDX analysis. On the contrary, it has been found the same composition of dark blue (Na, Al, Si, S, Ca, Ti, Fe and Zn). (fig.24b)

EDS analyses of the **Green pigment** (fig.24c) reveals the presence of Na, As, Al, Ca, Ba, Cr, Fe, Cu, Zn, Pb which leads to characterize the blue color was formed by mixing Veronese green $\text{Cu}_3(\text{AsO}_4)_2 \cdot 4\text{H}_2\text{O}$ with Viridian $\text{Cr}_2\text{O}_3 \cdot 2\text{H}_2\text{O}$.

In the EDX analyses of the **yellow pigment** sample amounts of lead (Pb), Cr, Ba, Zn, Al, Si and calcium (Ca) were observed (Fig.24d). Yellow color may be produced by lead chromium oxide, crocoite, PbCrO_4 .

The elemental composition analysis of the **Brown pigment** indicate that they are mainly composed of zinc (Zn), iron (Fe), K, Cl, S, Si,) and aluminum (Al) (fig.24e). The less amounts of iron may show the use of iron containing pigments such as iron oxide. The aluminum in the paint layer can be explained as impurity found in the iron compounds or from dirt layer which covered the surface. According to (Buxbaum 1998), variation of the zinc to iron ratio gives light to medium brown pigments.

The EDX analysis of **Beige pigment** which has been collected from Christ's neck reviles amount of Zn, Fe, Si Ti, S and Cl. According these results, the beige color may be produced by mixed of titanium zinc and iron, (fig.24f).

The EDX analysis of **Silver pigment** which has been collected from the ground around the Apostles on the barrel of dome reviles high percentage of aluminum (Al), sulphure (S), chloride (Cl), calcium (Ca), zinc (Zn) which leads to characterize the silver color formed by aluminum sulfate ($\text{Al}_2[\text{SO}_4]_3$). Aluminum sulfates are described in the chemical and pigment literature as white or silver color, the Color Index (1971) gives CI 77002/Pigment White 24 as 'aluminum hydroxide with varying amounts of basic aluminum sulfate (Eastaugh 2004). The presence of Ca related to preparation layer, the presence of Al related to the accumulation of airborne deposits and the presence of cl related to salts, (fig.24g).

The examination of the **gilded layer** in the dome of St. George church by EDX showed high percentage of Au (35.22) and Zn (9.53) and low percentage of Ca, Ag, K, Fe and Cl (fig.24h). Sample indicating that the gilded layer may be gold paper containing copper and Au as impurities. Most gold-leaf samples were alloyed with silver and gold, and just one contained only copper in addition to the gold (Payer et al 1994).

Figure 24: DEX pattern of mural painting structure at St. George Church A: dark blue B: light blue C: green pigment D: yellow pigment E: brown pigment, f: beige pigment, G : silver pigment H: Golden layer.

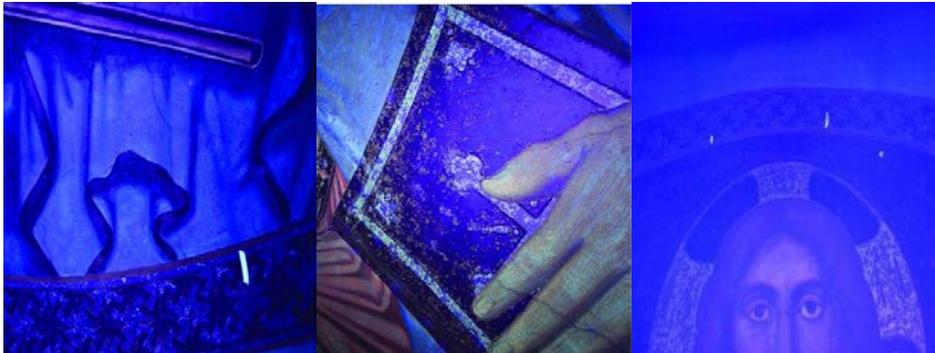
Figure 26: The analyses and UV diagnosis showed, as it was expected, that the pigments were the usual ones

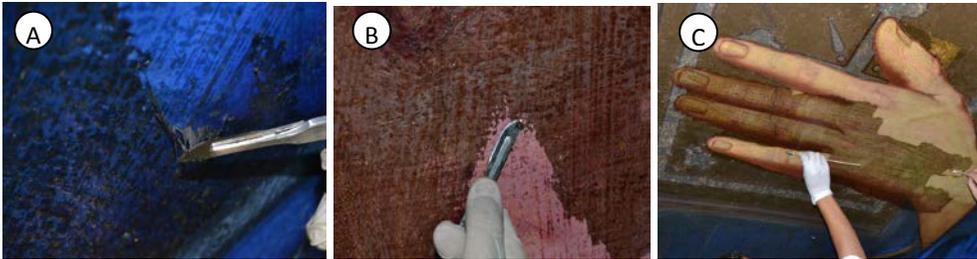
Figure 27: Different aspects during the removing of the varnish layer from mural painting at St. George dome.

According to above analysis, the mural paintings of St. George were carried out by oil painting technique, its surfaces was coated with varnish layer of dammar resin, the varnish layer was the original one and it was unique and no other coatings or additional layers were observed on the painted surface. The varnish layer was in an extremely terrible condition and thick with several physical damages such as severe scratches and detachments at discrete sites of the surface. In addition, it had an intense yellowish hue indicative of its oxidative and polymerized state. Apart from the damaged structure layers, the varnish was also affected. In addition, the existence of soot on the varnish layer proclaimed that it was slightly burnt, possibly from candles. The application of varnish layers has been shown to play a significant role in protecting painted surfaces (Stolow 1985). During aging, the varnish degrades through oxidation, auto-oxidation and crosslinking processes, catalyzed by the absorption of light (De La Rie1988). Owing to preservation reasons, the artwork must be relieved from the degraded varnish that can affect the inner layers (Theodorakopoulos & Zafiropulos 2003). Mechanical and chemical cleaning was used to remove the old degraded varnish. Scalpels were used for removing the thick parts of varnish layer as shown in (fig.28a). The solubility tests of the varnish layers were performed on the basis of finding the least concentration of solvent in an inert medium, which would marginally dissolve the residual varnish. For the particular mixture of the solvent system, a series of solutions of varying concentrations were prepared. Mixture of Isopropyl alcohol, Spirits of Turpentine and acetone (1:1:1) proved to be the most useful solvent for the old varnish layer which the mechanical cleaning failed to remove (fig. 28b).The chemical cleaning showed, that the varnish removal from all zones (fig.28c,29).

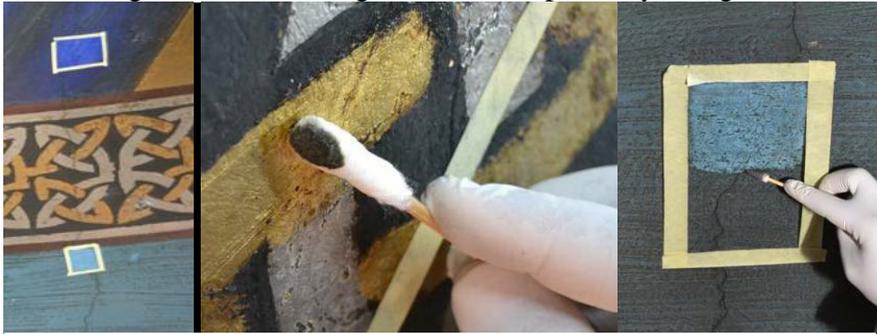
Figure 29: some initial tests were carried out to assess potential treatment options.

The cleaning revealed the colorful original paintings and focused substantially on the removal of extraneous substances which were impossible to distinguish for so many years due to the dirty covering layers, soot and stains. A wide range of techniques is available for cleaning mural painting, ranging from mechanical cleaning to chemical cleaning. Considering the paint layer's sensitivity to water, we used mainly dry **mechanical methods** using cotton swabs, different types of brushes, scalpels and wishab sponges until the expected result was obtained(fig.29). We tried to improve the results of the dry mechanical method using in parallel chemical cleaning. **The chemical cleaning** was completed where necessary. Several solvent mixtures were tried but the best results were obtained with mixture of ethyl alcohol, acetone, toluene and trichloroethylene used for removal of dirt. Some initial tests were carried out prior to the intervention for setting up the right methodology specific for each color and gold layer (fig.29). It was applied two or more times, for very short periods, usually from two to four minutes. With this method, however, it was difficult to actually lift the dirt off the surface. A poulticing system was then tested. This consisted of small cotton-wool compresses, wetted with the same solvent mixture, placed on an intervention layer of Japanese tissue, and left in contact with the paint surface for ten seconds. Poulticing was repeated two to three times, if

necessary (Fig.29). This proved to be highly effective in removing the dirt and the coating without affecting the sensitive paint layer (fig.30, 31).

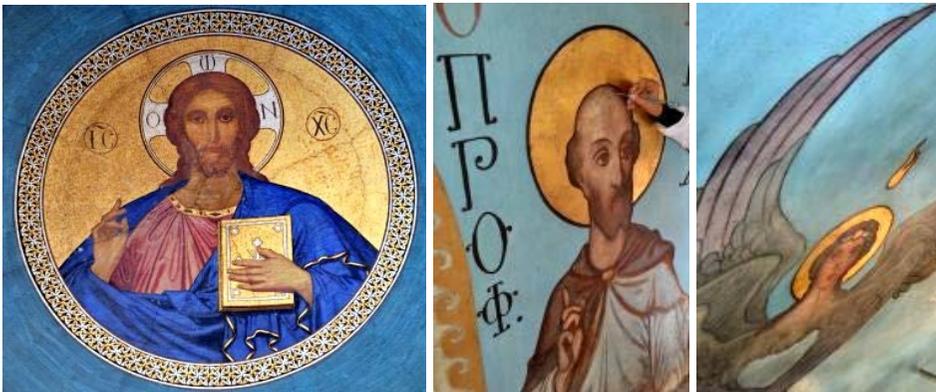
Figure38: mural painting after restoration.
