Physico-Chemical and Microbiological Qualities of Water From Wells, Drillings and Tanks Used as Drinking Water in the Municipality of Allada (Benin, West Africa)

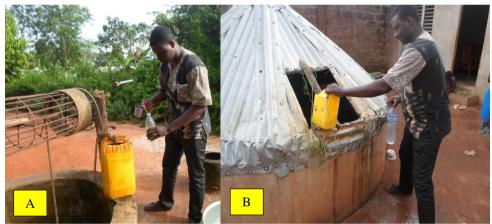
Photo 1 : Session of taking well water in big diameter at Sékou village (A) and tank at Hinvi (B) Shooting: Idani, in November, 2016

The sampling in these water samples was carried out in bottles of possotomé (Photo 1) to which was fixed a string making it possible to lower them in the well or the tank. For drilling water, the tap is thoroughly cleaned and then sterilized before setting. Water samples collected in 1.5 L were stored in a refrigerated cooler (4 $^{\circ}$ C) until the time of analysis.

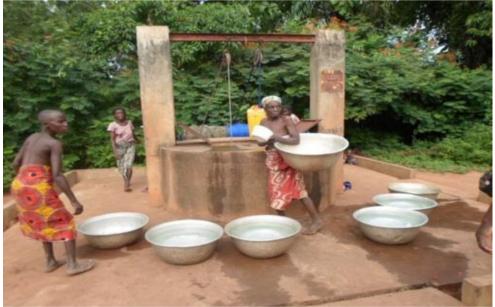
Photo 2: Women looking for drinking water at an unconditioned well in Lissègazoun Shooting: Sohounou, in November, 2016

This photo shows that the surroundings of the well are covered with vegetation that is less than one meter. Contamination of the well with aerobic pathogens cannot be ignored since it is exposed to everything that happens in its environment. The rural environment vegetation serves as the place of feces, so the risk of faecal contamination.
